LAND CONDITION ASSESSMENT

Smoky Creek Solar Farm

Appendix B

Project Number: J000283
Status: Final
Date: 27/09/2019

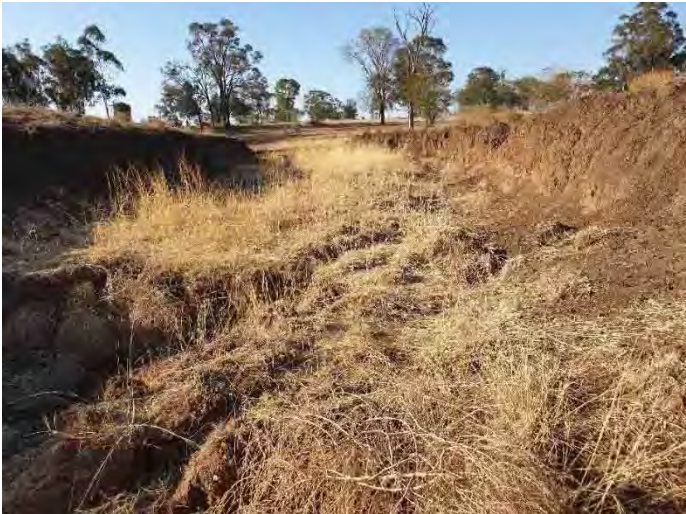
Erosion feature I.D	Description		Photograph
D_EF_1	Type of erosion feature	Gully

Lease Area	E	
	Landform	Simple slope	
	Location	Downgradient of Dam7	
	Soil Type (Muller, 2008)	Earlsfield	
	ALC (Thompson)	Class A	
	Soil Condition:	Cracking clay soils	
	Gully head coordinate	Latitude: -24.043813 Longitude: 150.405252	
	Maximum gully depth (m)	1.6	
	Maximum width (m)	11	
	Length (m)	170	
	Description	Contributing causes include concentrated flow from upgradient dam and limited groundcover.	
D_EF_4	Type of erosion feature	Erosion of bank of watercourse	
	Lease Area	E	
	Landform	Watercourse	
	Location	Northern bank	
	Soil Type (Muller, 2008)	Earlsfield	
	ALC (Thompson)	Class A	
	Soil Condition:	Cracking clay soils	
	Start of feature coordinate	Latitude: -24.043743 Longitude: 150.406647	
	Maximum depth (m)	1.3	
	Maximum width (m)	Not applicable	
	Length (m)	45

Erosion feature I.D	Description	Photograph
	<p>Description</p> <p>Contributing factors to the erosion of the northern bank of a watercourse include unstable ground surface condition and sidewall (low groundcover).</p>

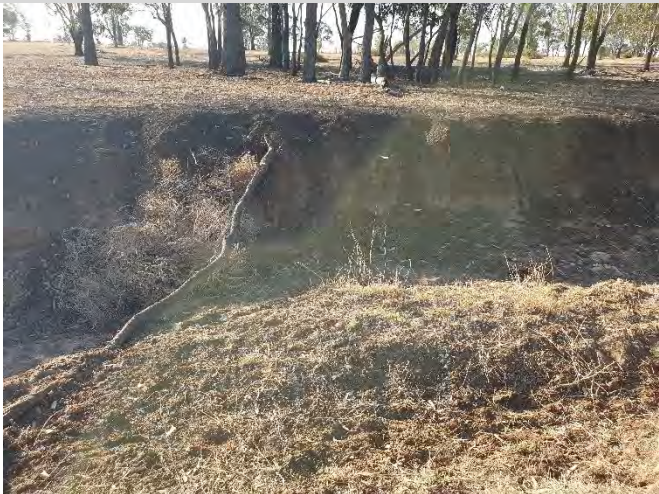
D_EF_3	Type of erosion feature	Anthropogenic
	Lease Area	E
	Landform	Crest
	Location	Downgradient of cattle yards
	Soil Type (Muller, 2008)	Kokotungo
	ALC (Thompson)	ALC C
	Soil Condition:	Texture contrast soils, sodic subsoil and shallow topsoil.
	Top of feature coordinate	Latitude: -24.0407578 Longitude: 150.408544
	Maximum depth (m)	2 m at cutting for vehicle access
	Maximum width (m)	90
	Length (m)	120

Erosion feature I.D	Description	Photograph
	<div> <div>Description</div> <div>Unstable sidewalls and limited upgradient groundcover.</div> </div>

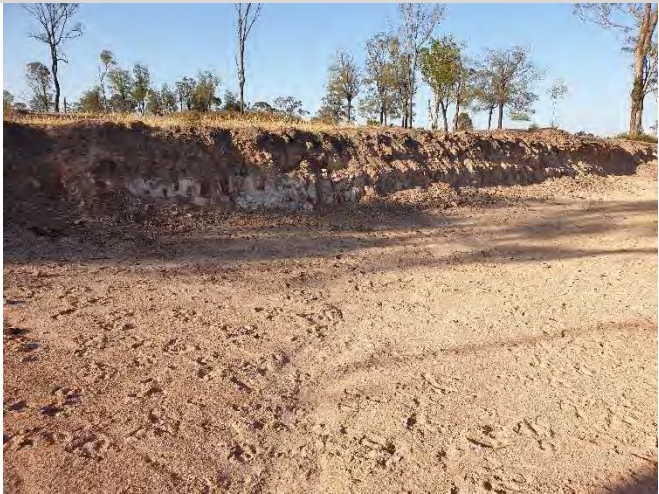
D_Rill_1	Type of erosion feature	Rill
	Lease Area	E
	Landform	Simple slope
	Location	Formed from cattle track
	Soil Type (Muller, 2008)	Annandale
	ALC (Thompson)	Class A
	Soil Condition:	Cracking clay soils
	Rill head coordinate	Latitude: -24.047835 Longitude: 150.418234
	Maximum depth (m)	0.4
	Maximum width (m)	3
	Length (m)	310

Erosion feature I.D	Description		Photograph
	Description	Rill erosion with head formed at cattle track. Gently inclined sidewalls.

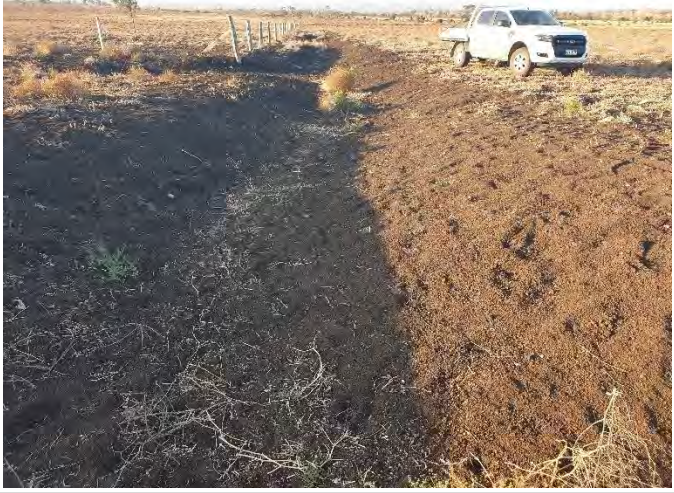
D_DF_1	Type of erosion feature	Erosion of bank of watercourse	
	Lease Area	E

Landform	Watercourse	
	Location	Banks	
	Soil Type (Muller, 2008)	Earlsfield & Annandale	
	ALC (Thompson)	Class A	
	Soil Condition:	Cracking clay soils	
	Start of feature coordinate	Latitude: -24.048862 Longitude: 150.415501	
	Maximum depth (m)	1.5	
	Maximum width (m)	8	
	Length (m)	935	
	Description	Contributing factors to the erosion of some banks of the watercourse

Erosion feature I.D	Description		Photograph
		include unstable ground surface conditions and sidewalls (low groundcover). Evidence of lateral bank erosion at some locations.	
D_EF_7	Type of erosion feature	Extensive erosion

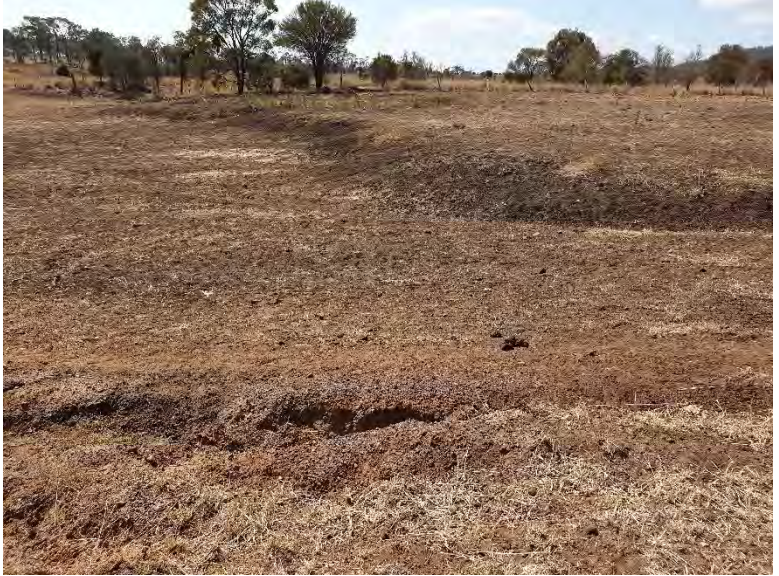
Erosion feature I.D	Description		Photograph
F_Rill_1	Type of erosion feature	Rill

Lease Area	C	
	Landform	Lower slope	
	Location	Adjoining Dodsons Road	
	Soil Type (Muller, 2008)	Kokotungo	
	ALC (Thompson)	Class C	
	Soil Condition:	Friable non-cracking clay or clay loam soils	
	Rill head coordinate	Latitude: -24.044339 Longitude: 150.400246	
	Maximum depth (m)	0.5	
	Maximum width (m)	30	
	Length (m)	110	
	Description	Contributing factors to the erosion included low groundcover and cattle traffic.	
F_EF_1	Type of erosion feature	Erosion of banks of watercourse and lateral bank erosion and gullies.	
	Lease Area	G2	
	Landform	Watercourse	
	Location	Watercourse from property to the east across Dodsons Road	
	Soil Type (Muller, 2008)	Kokotungo & Kokotungo-Greycliffe complex	
	ALC (Thompson)	Class A & C	
	Soil Condition:	Friable non-cracking clay or clay loam soils and cracking clay soils.	
	Top of feature coordinate	Latitude: -24.043596 Longitude: 150.401046

Maximum width (m)	14	
	Length (m)	2.1 km	
	Description	<p>Contributing factors to the erosion included low groundcover, concentrated flow from dams, including upgradient, cattle traffic and sodic subsoils at some locations.</p> <p>Unstable head and sidewalls and limited upgradient groundcover.</p>

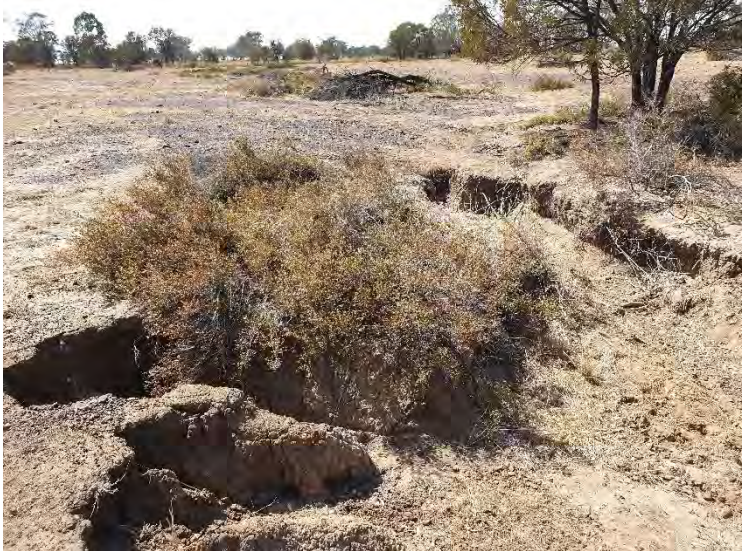
Erosion feature I.D	Description		Photograph
F_EF_3	Type of erosion feature	Gully

Lease Area	C	
	Landform	Lower slope	
	Location	Adjoining Dodsons Road	
	Soil Type (Muller, 2008)	Kokotungo	
	ALC (Thompson)	Class C	
	Soil Condition:	Friable non-cracking clay or clay loam soils	
	Head of gully coordinate	Latitude: -24.041294 Longitude: 150.399831	
	Maximum depth (m)	0.6	
	Maximum width (m)	8	
	Length (m)	20	
	Description	Contributing factors to the erosion included low groundcover and sodic subsoils. Unstable head and sidewalls and limited upgradient groundcover.	
F_Gully_3	Type of erosion feature	Gully	
	Lease Area	C	
	Landform	Simple slope	
	Location	Adjoining Dodsons Road	
	Soil Type (Muller, 2008)	Kokotungo	
	ALC (Thompson)	Class A	
	Soil Condition:	Friable non-cracking clay or clay loam soils	
	Head of gully coordinate	Latitude: -24.034123 Longitude: 150.382404	
	Maximum depth (m)	0.6	
	Maximum width (m)	6

Length (m)	40

Erosion feature I.D	Description		Photograph
	Description	Contributing factors to the erosion included low groundcover and concentrated flow from upgradient dam.

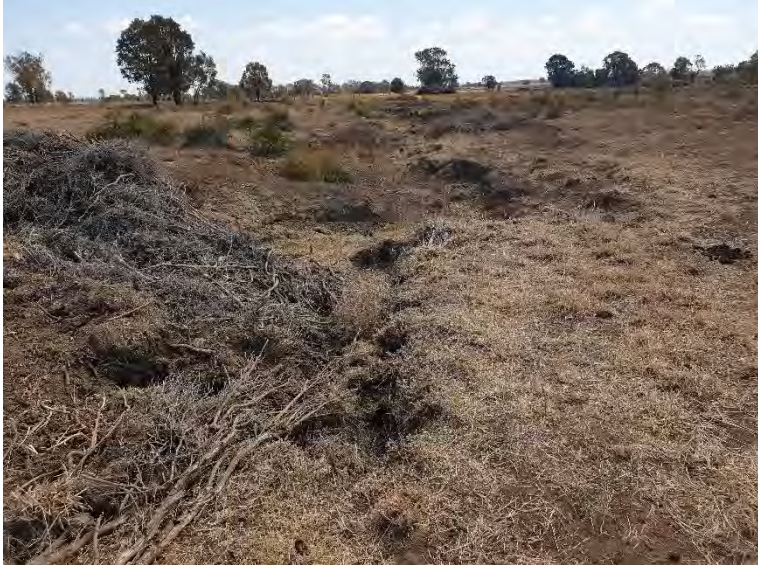
F_Gully_1	Type of erosion feature	Gully	
	Lease Area	C	
	Landform	Simple slope	
	Location	Upgradient of dams	
	Soil Type (Muller, 2008)	Greycliffe (including Melonhole Phase)	
	ALC (Thompson)	ALC C	
	Soil Condition:	Cracking clay soils	
	Head of gully coordinate	Latitude: -24.034631 Longitude: 150.378544	
	Maximum depth (m)	0.6	
	Maximum width (m)	10	
	Length (m)	20

Erosion feature I.D	Description		Photograph
	Description	Contributing factors to the erosion included low groundcover and cattle traffic.

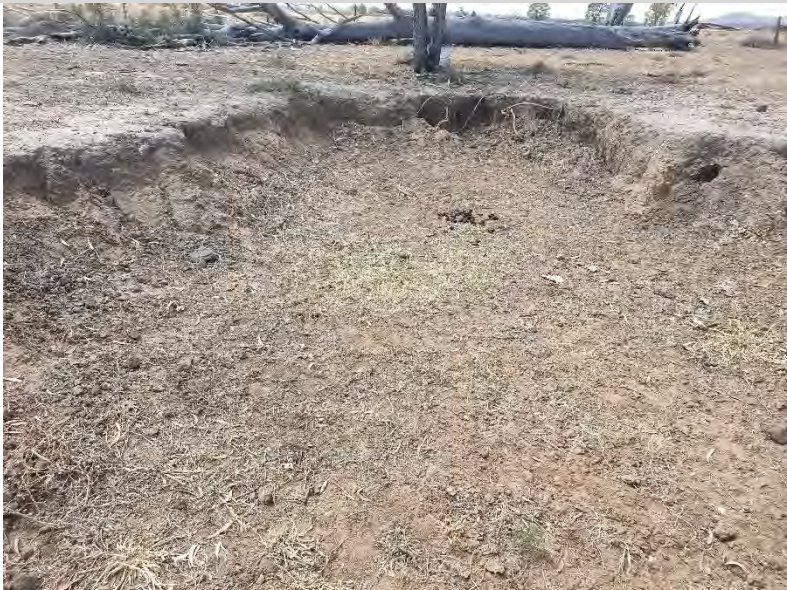
F_Gully_2	Type of erosion feature	Gully	
	Lease Area	C	
	Landform	Simple slope	
	Location	Upgradient of dams	
	Soil Type (Muller, 2008)	Greycliffe (including Melonhole Phase)	
	ALC (Thompson)	ALC C	
	Soil Condition:	Cracking clay soils	
	Head of gully coordinate	Latitude: -24.035096 Longitude: 150.3784	
	Maximum depth (m)	1	
	Maximum width (m)	6	
	Length (m)	10

Erosion feature I.D	Description		Photograph
	Description	Contributing factors to the erosion included low groundcover and cattle traffic. Unstable head and sidewalls and limited upgradient groundcover.

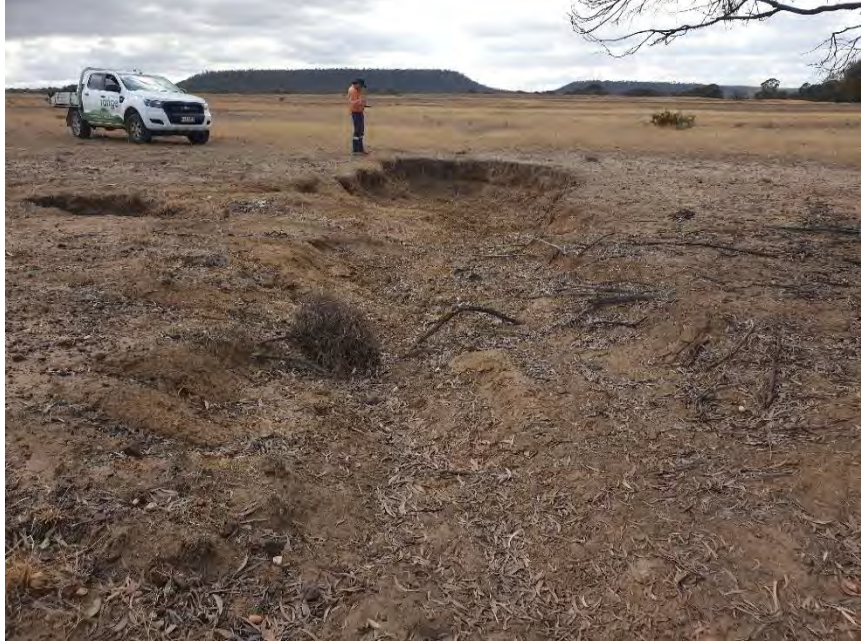
Erosion feature I.D	Description		Photograph
M_Gully_1	Type of erosion feature	Gully

Lease Area	A	
	Landform	Plain	
	Location	North of Dam17	
	Soil Type (Muller, 2008)	Kokotungo	
	ALC (Thompson)	Class A	
	Soil Condition	Texture contrast soils, sodic subsoil and shallow topsoil.	
	Gully head coordinate	Latitude: -24.067906 Longitude: 150.377679	
	Maximum depth (m)	0.5	
	Maximum width (m)	10	
	Length (m)	120	
	Description	Contributing factors to the erosion included contour banks and sodic subsoils. Unstable head and sidewalls (including of banks) and limited upgradient groundcover.	
M_Gully_2	Type of erosion feature	Gully	
	Lease Area	A	
	Landform	Plain	
	Location	Upgradient of Dam18	
	Soil Type (Muller, 2008)	Kokotungo	
	ALC (Thompson)	Class A

Gully head coordinate	Latitude: -24.06052 Longitude: 150.387346	
	Maximum depth (m)	1.5	
	Maximum width (m)	18	
	Length (m)	460	
	Description	<p>Contributing factors to the erosion included contour banks and sodic subsoils.</p> <p>Unstable head and sidewalls (including of banks) and limited upgradient groundcover.</p> <p>Secondary gullies formed along contour banks.</p> <p>Gully includes several secondary heads.</p>

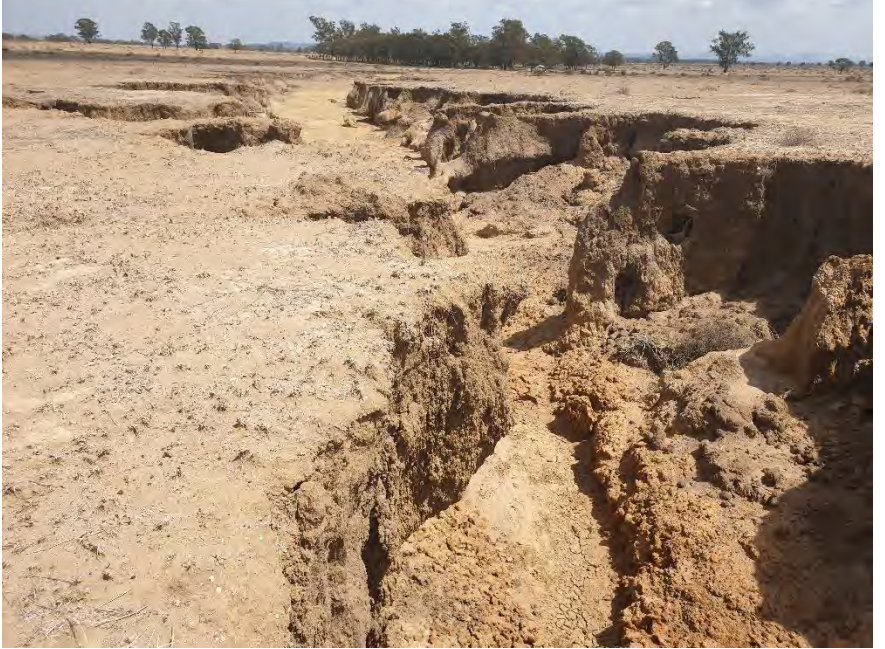
Erosion feature I.D		Description	Photograph
M_Gully_3	Type of erosion feature	Gully

Lease Area	A	
	Landform	Open depression	
	Location	Upgradient of Dam18	
	Soil Type (Muller, 2008)	Kokotungo	
	ALC (Thompson)	Class A	
	Soil Condition	Texture contrast soils, sodic subsoil and shallow topsoil.

Maximum depth (m)	0.5	
	Maximum width (m)	8	
	Length (m)	80	
	Description	Contributing factors to the erosion included contour banks and sodic subsoils.	
M_Gully_4	Type of erosion feature	Gully

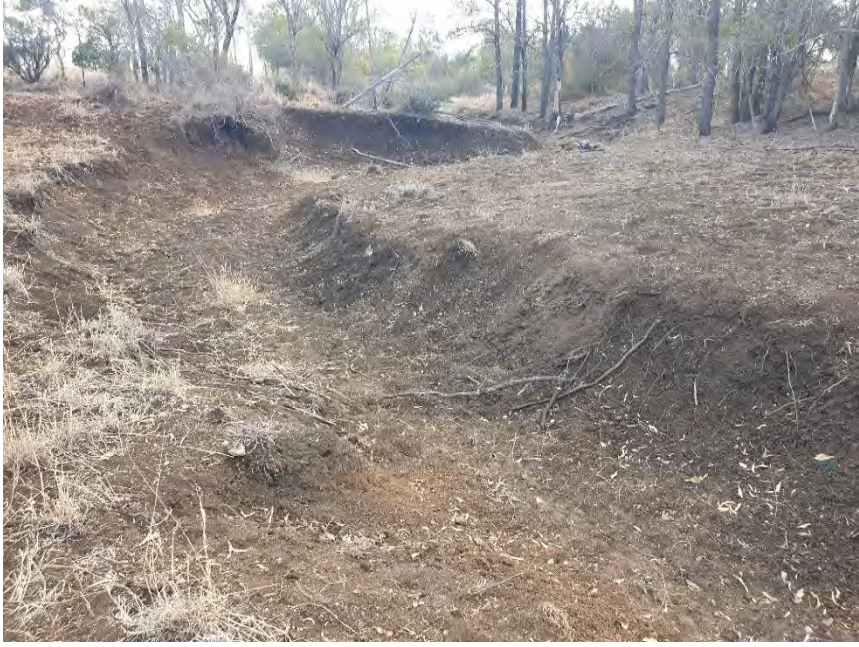
Erosion feature I.D	Description		Photograph
	Start of feature coordinate	Latitude: -24.060367 Longitude: 150.440836 Note: start of feature at eastern lease boundary

Maximum depth (m)	1.-1.2	
	Maximum width (m)	10	
	Length (m)	860	
	Description	Contributing factors to the erosion included concentrated flow, low groundcover and cattle traffic.
