Edify Energy – Development Plans

PROJECT
SMOKY CREEK SOLAR PROJECT

LAND CONDITION ASSESSMENT Smoky Creek Solar Farm

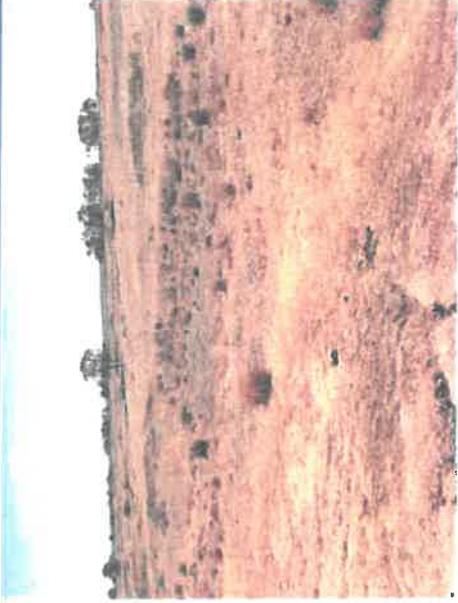
Constraint	Description	Soils	Representative Photograph
Gilgai microrelief (melonholes)	<ul style="list-style-type: none"> Gilgai are depressions that form in the surface of cracking clay soils (Vertosols). They can hold water during wet conditions. Continuous cultivation can level out some shallow gilgai. But they will reform if the ground is left undisturbed. Gilgai soil profiles include soils that are dispersive, very strongly acid and moderately saline. Melonhole gilgai were observed in the field to commonly be greater than 0.5 m deep and at least several metres wide. Soils that form gilgai occur across 20% of the lease areas 	<p>Beldeen, Greycliffie and Greycliffie Melonhole Phase.</p>

<p>View to the north of gilgai microrelief</p>

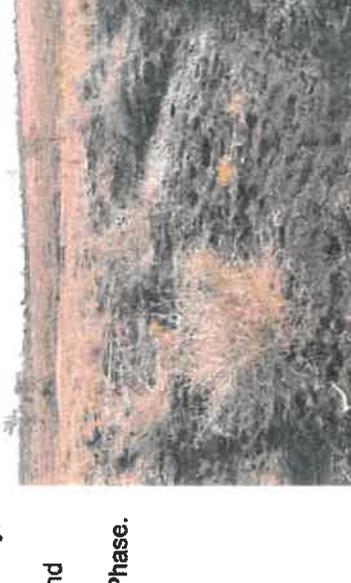
Constraint	Description	Soils	Representative Photograph
Shrink swell soils	<ul style="list-style-type: none"> Shrink-swell soils (or cracking clay soils) move or react to soil moisture. Infrastructure engineering designs need to account for soil movement by shrink-swell soils. Shrink swell soils occur across 39% of the lease areas. 	Annandale, Belldean, Ciancy, Earlsfield, Greycliffe and Greycliffe Melonhole Phase.

Example of shrink swell (Vertisol) soils

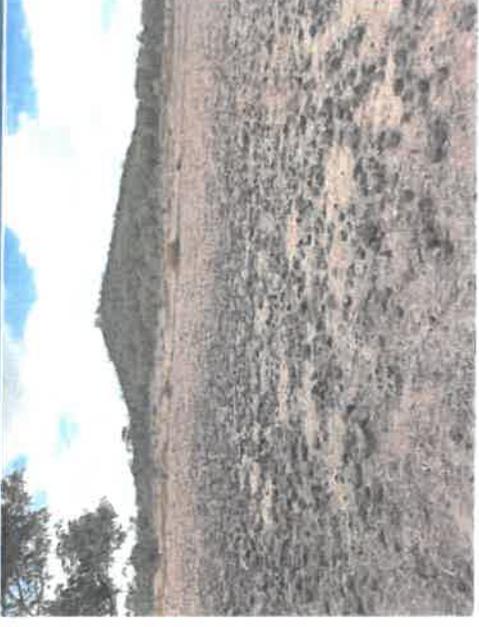
Constraint	Description	Soils	Representative Photograph
<p>Surface rock</p> <ul style="list-style-type: none"> • Dense surface rock was observed in parts of the lease areas. Rocks ranged in size from medium pebbles (6-20mm) to stones (60-200 mm). • Surface rock can impede cultivation practices. 	<p>Soils</p> <p>Kokotungo, Spier, Ulogie and Annandale</p>

<p>Example of dense surface rock cover.</p>

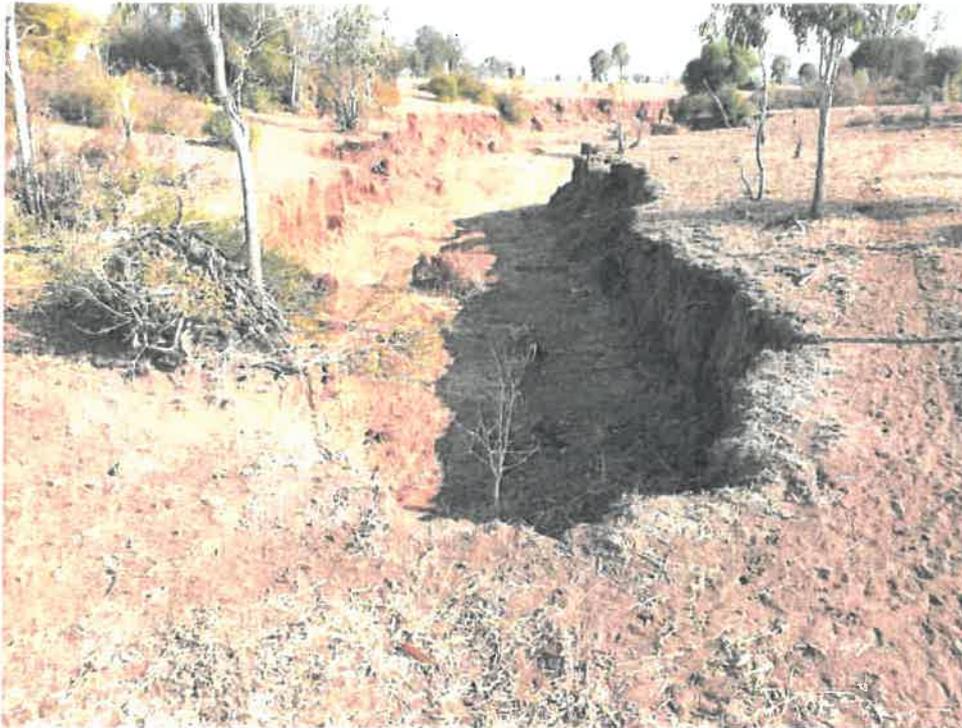
Photograph 1 View to the west of a gully head with limited adjoining groundcover

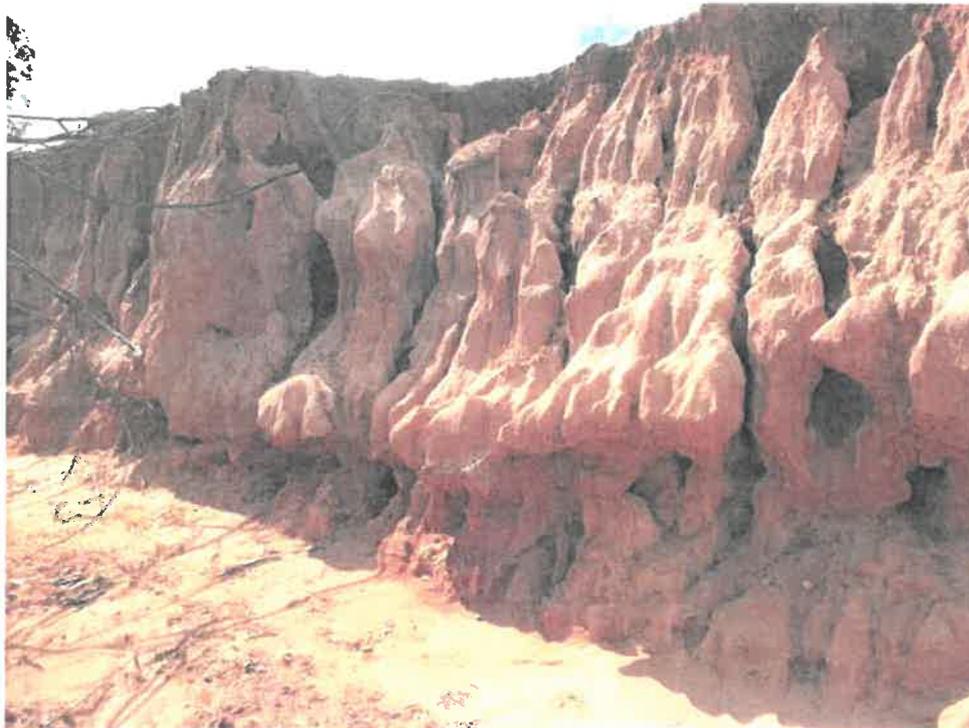
Photograph 2 View to the north of a gully sidewall in dispersive soils

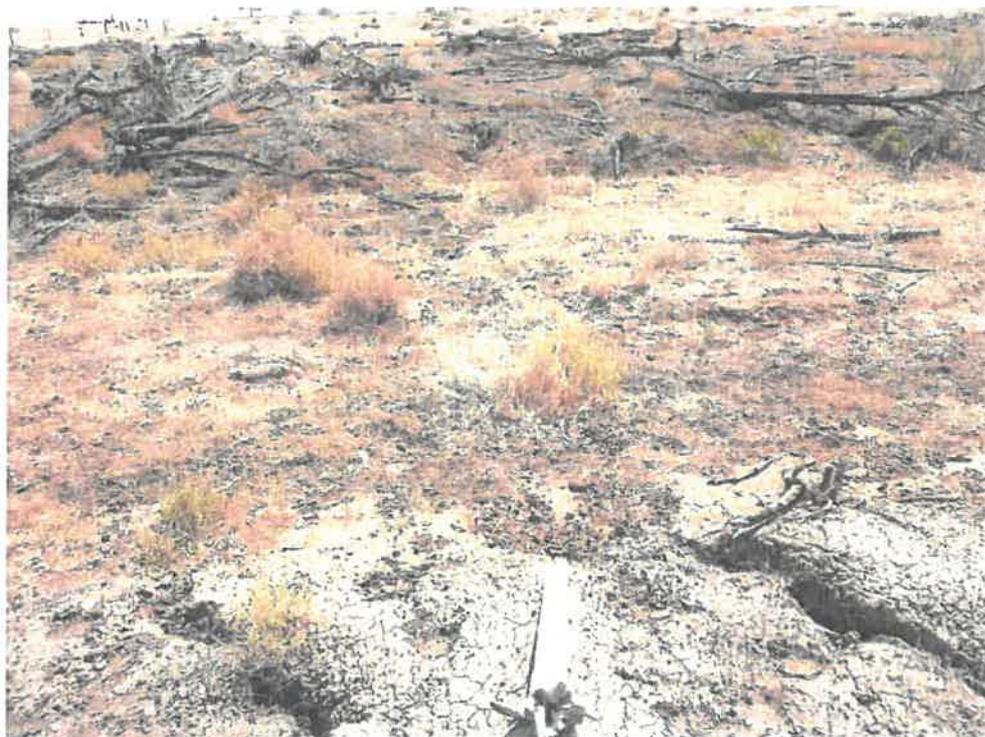
Photograph 4 View to the north of cleared trees along a drainage line

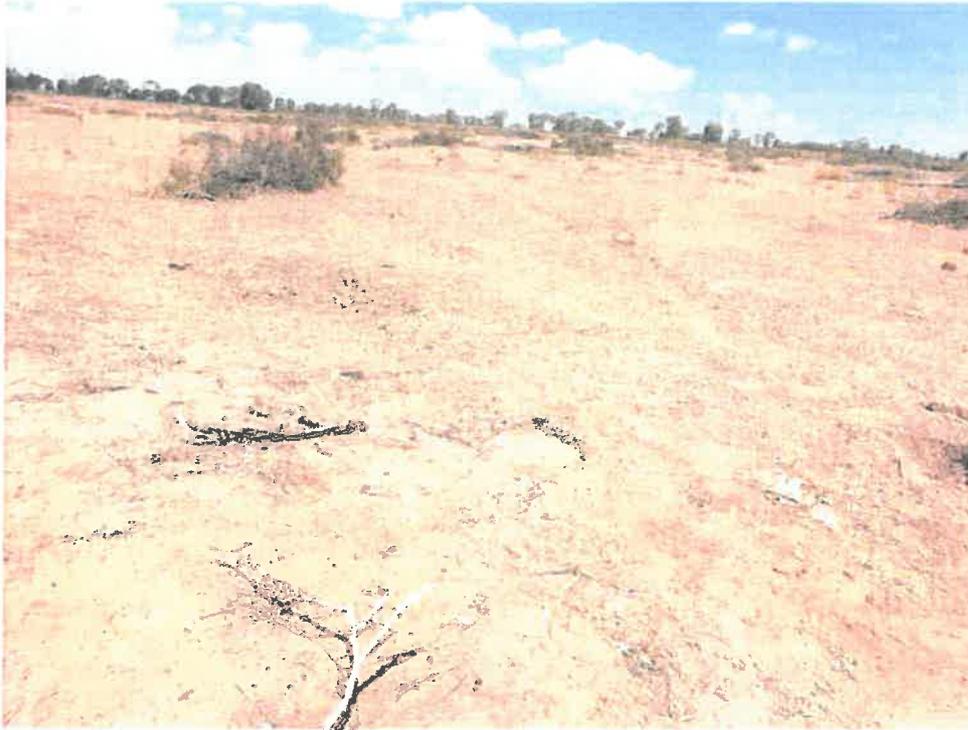
Photograph 5 View to the south of low groundcover due to drought conditions

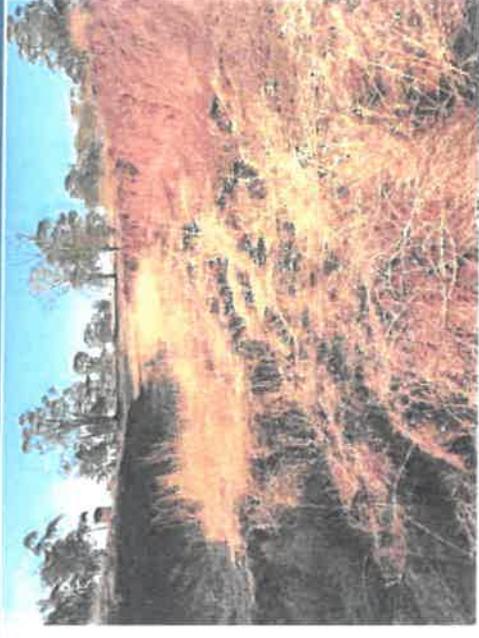
D_EF_1	<p>Type of erosion feature Lease Area Landform Location Soil Type (Muller, 2008) ALC (Thompson) Soil Condition: Gully head coordinate</p> <p>Maximum gully depth (m) Maximum width (m) Length (m) Description</p>	<p>Gully E Simple slope Downgradient of Dam7 Earlsfield Class A Cracking clay soils Latitude: -24.043813 Longitude: 150.405252</p> <p>1.6 11 170 Contributing causes include concentrated flow from upgradient dam and limited groundcover. Erosion of bank of watercourse</p>
D_EF_4	<p>Type of erosion feature Lease Area Landform Location Soil Type (Muller, 2008) ALC (Thompson) Soil Condition: Start of feature coordinate</p> <p>Maximum depth (m) Maximum width (m) Length (m)</p>	<p>E Watercourse Northern bank Earlsfield Class A Cracking clay soils Latitude: -24.043743 Longitude: 150.406647</p> <p>1.3 Not applicable 45</p>

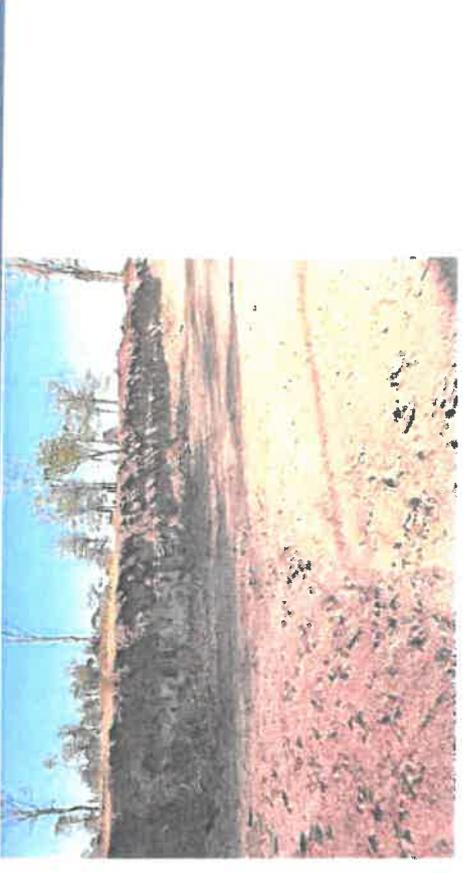
Unstable sidewalls and limited upgradient groundcover.

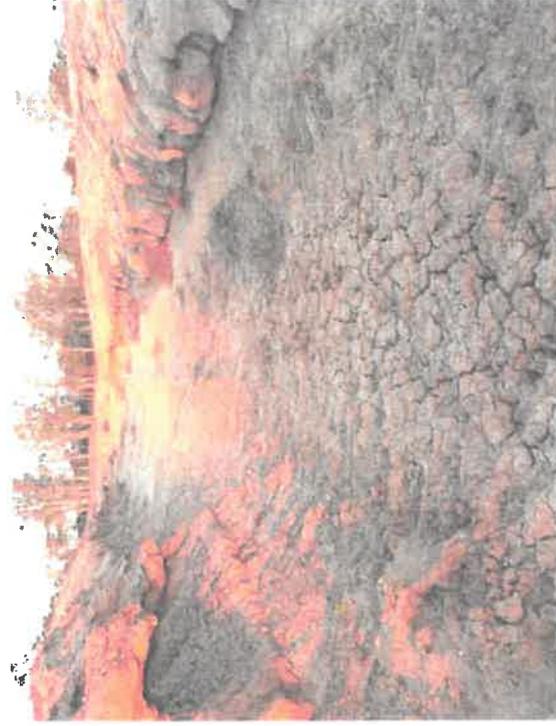
Erosion feature I.D	Description	Photograph
D_DF_6	<p>Watercourse and lower slope Downgradient of Dam Kokotungo ALC A Texture contrast soils, sodic subsoil and shallow topsoil. Latitude: -24.0484 Longitude: 150.425296 Range from <0.5->2 50 1.56 Contributing causes include concentrated flow from upgradient watercourses and dams, groundcover and dispersive subsoils. Unstable sidewalls and limited upgradient groundcover. Evidence of lateral bank erosion at some locations. Erosion of banks of watercourse & rill G2 Watercourse & lower slope Gully erosion formed at upgradient property east of the site and extended onto the site. Clancy</p>

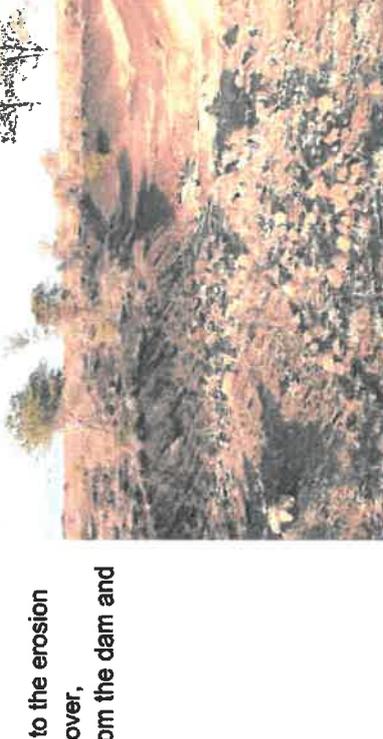
D_DF_4	<p>Type of erosion feature Lease Area Landform Location Soil Type (Muller, 2008) ALC (Thompson) Soil Condition: Start of feature coordinate</p>	<p>Erosion of banks of watercourse G2 Watercourse, upper to lower slopes Gully erosion formed at upgradient property north of the site and extended onto the site. Santo Class C Friable non-cracking clay or clay loam soils Latitude: -24.038453 Longitude: 150.435185</p>

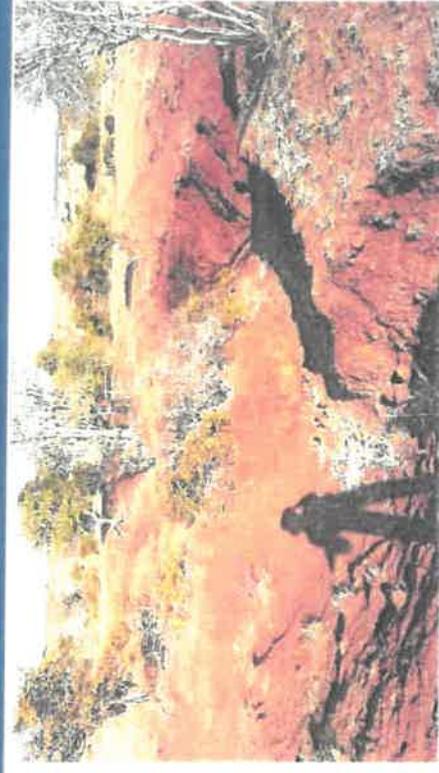
1
 14
 450
 Contributing factors to the erosion included low groundcover and steep slope.
 Unstable sidewalls and limited upgradient groundcover.

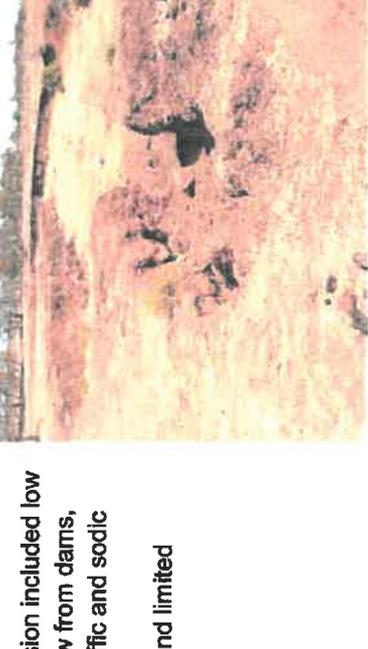
Contributing factors to the erosion included low groundcover, concentrated flow from dams, including upgradient, cattle traffic and sodic subsoils at some locations. Unstable head and sidewalls and limited upgradient groundcover.

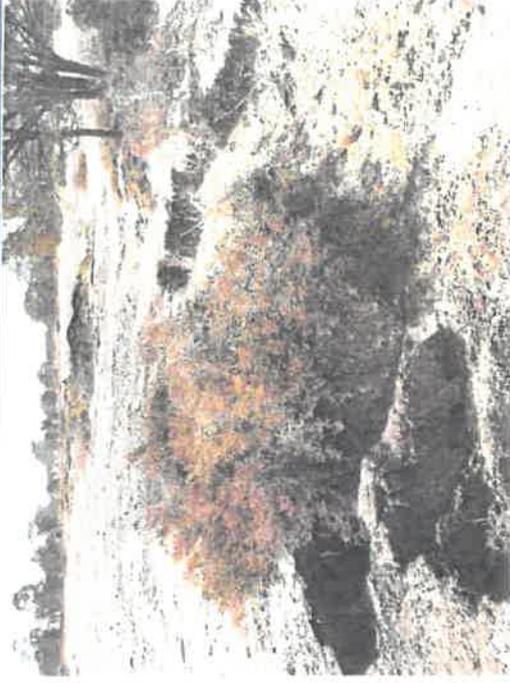
F_Gully_3	<p>Type of erosion feature Lease Area Landform Location Soil Type (Muller, 2008) ALC (Thompson) Soil Condition: Head of gully coordinate Maximum depth (m) Maximum width (m) Length (m)</p>	<p>Gully C Simple slope Adjoining Dodsons Road Kokotungo Class A Friable non-cracking clay or clay loam soils Latitude: -24.034123 Longitude: 150.382404 0.6 6 40</p>

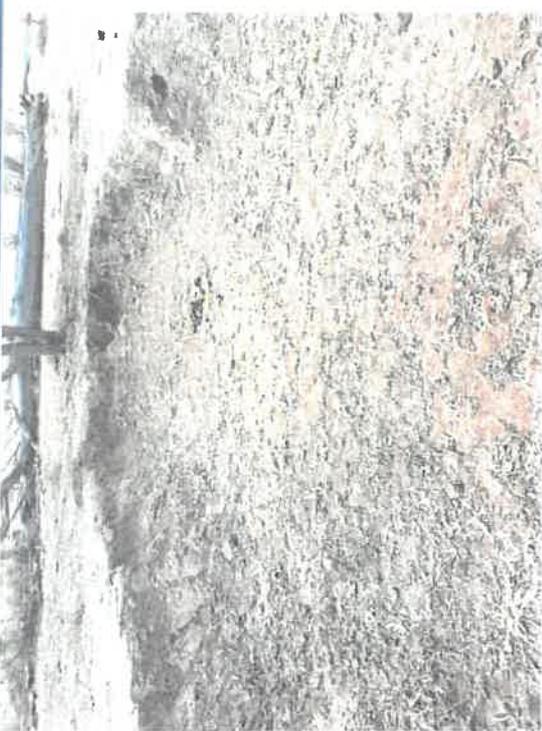
Contributing factors to the erosion included low groundcover and cattle traffic.

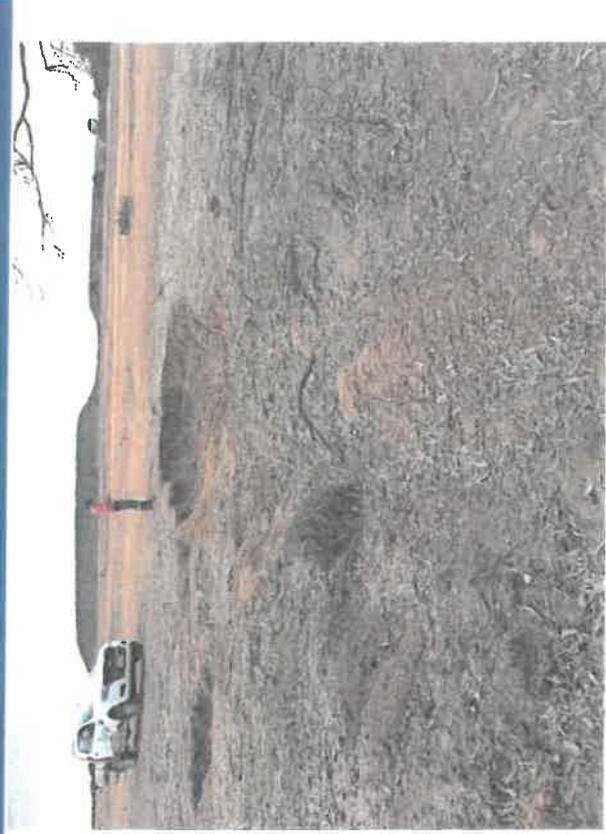
M_Gully_1	<p>Type of erosion feature Lease Area Landform Location Soil Type (Muller, 2008) ALC (Thompson) Soil Condition</p> <p>Gully head coordinate Maximum depth (m) Maximum width (m) Length (m) Description</p>	<p>Gully A Plain North of Dam17 Kokotungo Class A Texture contrast soils, sodic subsoil and shallow topsoil. Latitude: -24.067906 Longitude: 150.377679 0.5 10 120 Contributing factors to the erosion included contour banks and sodic subsoils. Unstable head and sidewalls (including of banks) and limited upgradient groundcover.</p>
------------------	--------------------------------------------------------------------------------------------------------------------------------------------------------------------------------------------------------------------------------------------------------------	-------------------------------------------------------------------------------------------------------------------------------------------------------------------------------------------------------------------------------------------------------------------------------------------------------------------------------------------------------------------------------------------------------------

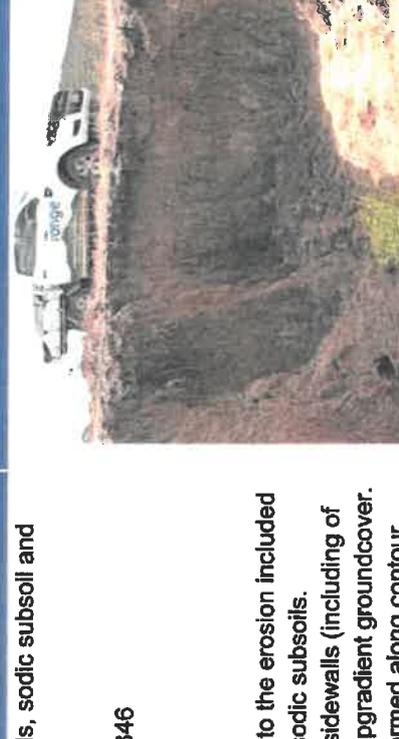
Gully head coordinate	Latitude: -24.06052 Longitude: 150.387346	
Maximum depth (m)	1.5	
Maximum width (m)	18	
Length (m)	460	
Description	Contributing factors to the erosion included contour banks and sodic subsoils. Unstable head and sidewalls (including of banks) and limited upgradient groundcover. Secondary gullies formed along contour banks. Gully includes several secondary heads.

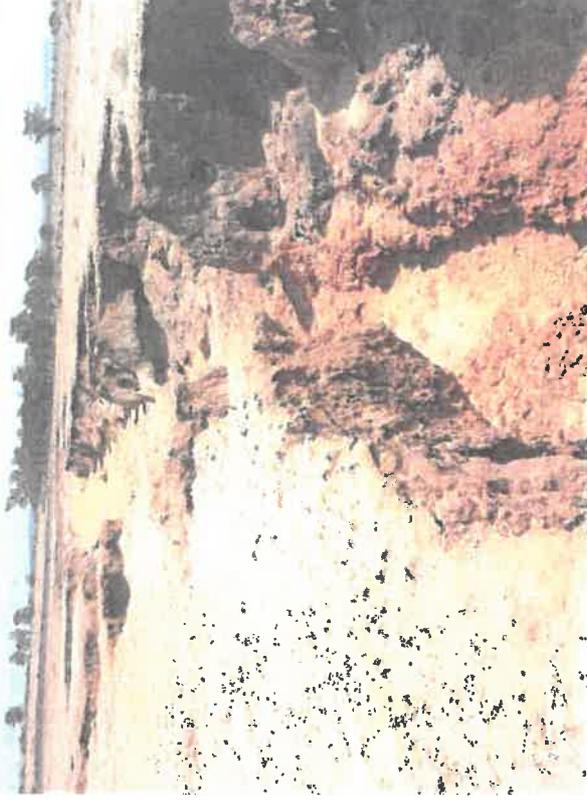
M_Gully_3	<p>Type of erosion feature</p> <p>Lease Area</p> <p>Landform</p> <p>Location</p> <p>Soil Type (Muller, 2008)</p> <p>ALC (Thompson)</p> <p>Soil Condition</p>	<p>Gully</p> <p>A</p> <p>Open depression</p> <p>Upgradient of Dam18</p> <p>Kokotungo</p> <p>Class A</p> <p>Texture contrast soils, sodic subsoil and shallow topsoil.</p>
------------------	--------------------------------------------------------------------------------------------------------------------------------------------------------------	---------------------------------------------------------------------------------------------------------------------------------------------------------------------------

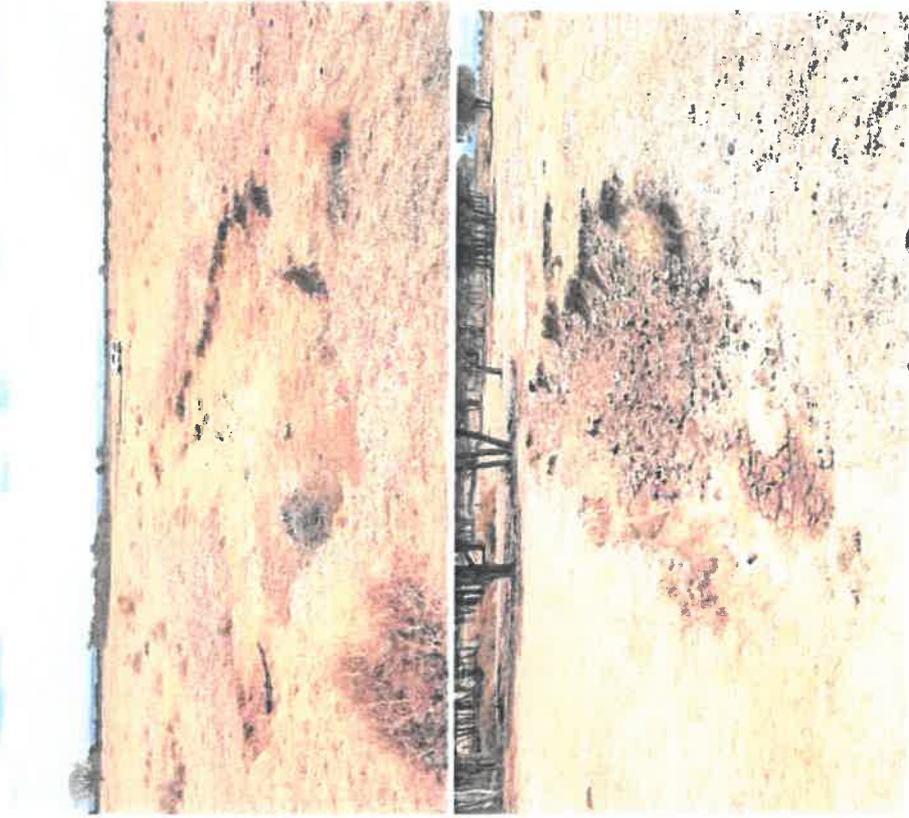
M_Gully_4
 Type of erosion feature Gully
 Lease Area A
 Landform Lower slope
 Location Upgradient of Dam 18
 Soil Type (Muller, 2008) Kokotungo
 ALC (Thompson) Class A
 Soil Condition Texture contrast soils, sodic subsoil and shallow topsoil.
 Gully head coordinate Latitude: -24.059453
 Longitude: 150.382186
 Maximum depth (m) 1
 Maximum width (m) 6

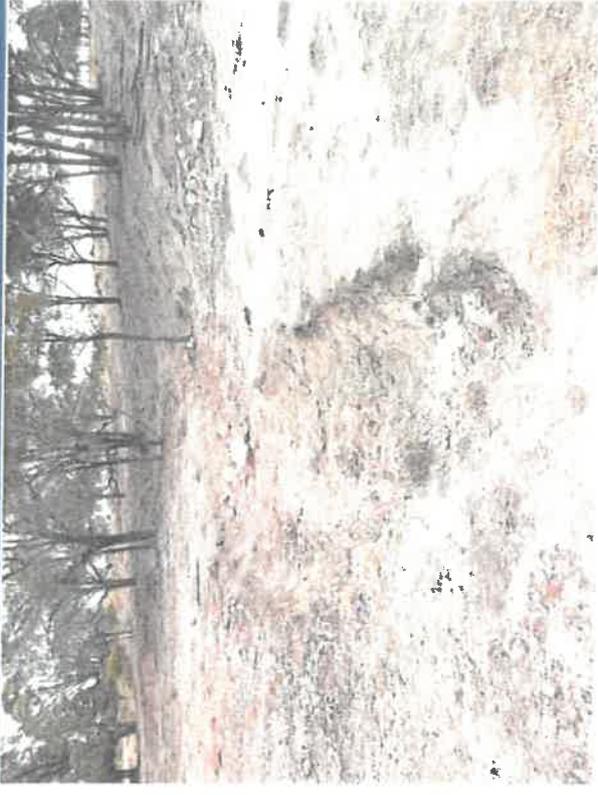
M_Sheet_2
 Type of erosion feature Sheet erosion
 Lease Area A
 Landform Crest
 Location Upgradient of Dam14
 Soil Type (Muller, 2008) Spier & Kokotungo
 ALC (Thompson) Class A
 Soil Condition Texture contrast soils, sodic subsoil and shallow topsoil.

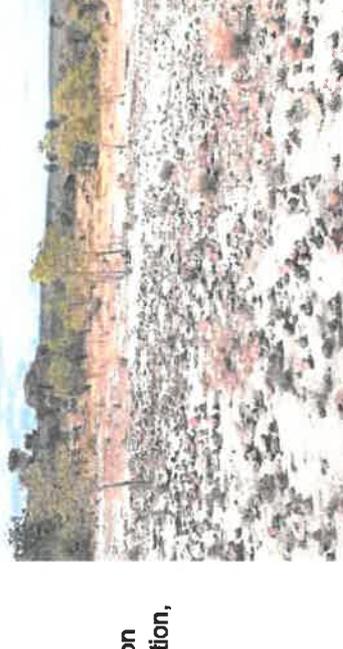
<p>Type of erosion feature Lease Area Landform Location Soil Type (Muller, 2008) ALC (Thompson) Soil Condition Top of sheet coordinate Maximum depth (m)</p>	<p>Sheet A Simple slope Upgradient of Dam14 and drainage feature (M_DF_1) Spier Class A Texture contrast soils, sodic subsoil and shallow topsoil. Latitude: -24.069642 Longitude: 150.38928 NA</p>

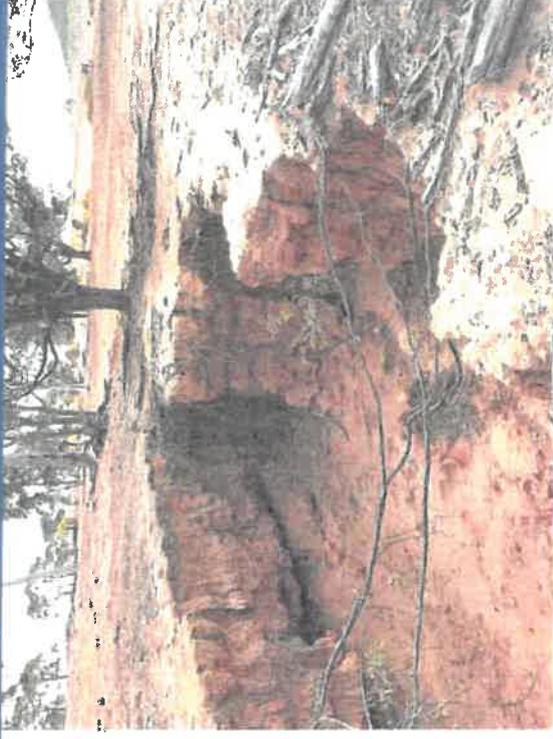
M_DF_2	Type of erosion feature	Sheet
Lease Area	Open depression adjoining watercourse	A
Landform	East of drainage feature	Kokotungo
Location	Kokotungo	Class A
Soil Type (Muller, 2008)	Texture contrast soils, sodic subsoil and shallow topsoil.	Latitude: -24.070707
ALC (Thompson) Soil Condition	Top of feature coordinate	Longitude: 150.384056

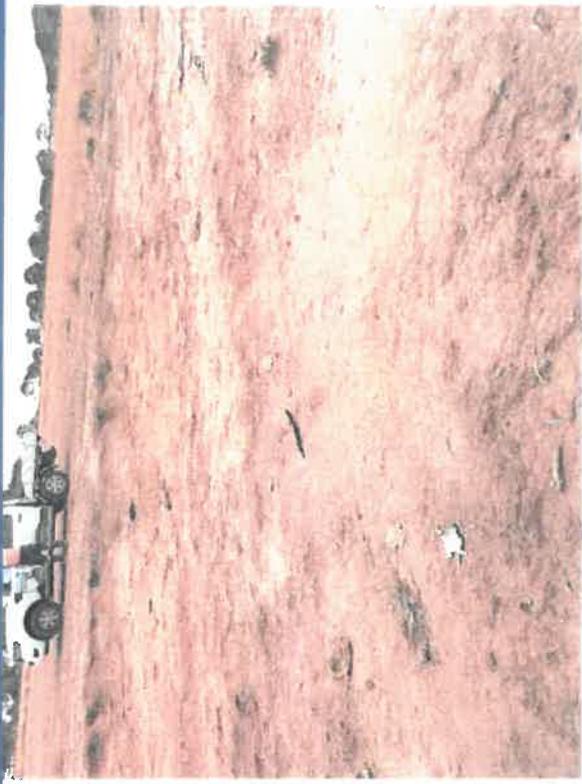
M_Gully_7	Type of erosion feature	Gully
	Lease Area	B1 & B2
	Landform	Simple slope
	Location	South of Dodson's Road
	Soil Type (Muller, 2008)	Eartsville
	ALC (Thompson)	Class A
	Soil Condition	Friable non-cracking clay or clay loam soils
	Top of gully coordinate	Latitude: -24.052188 Longitude: 150.411517

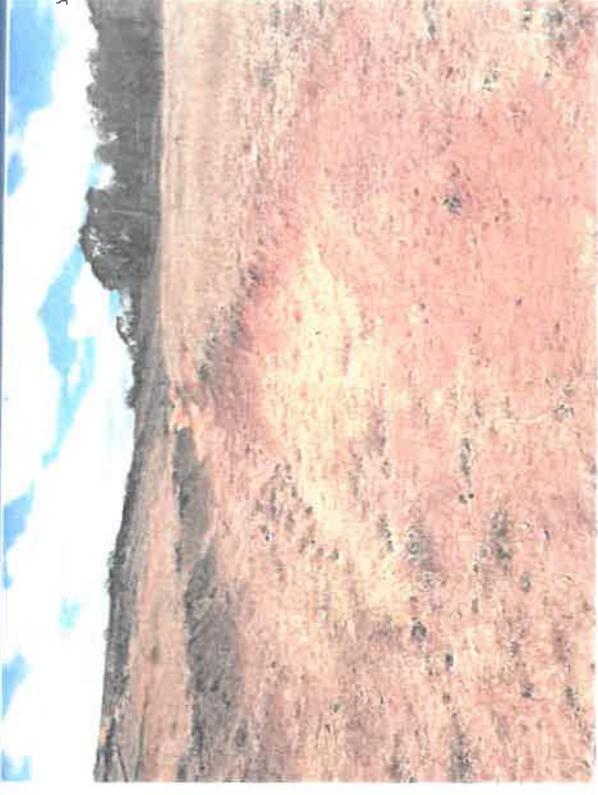
M_Gully_8
 Type of erosion feature Gully
 Lease Area B2
 Landform Simple slope
 Location Upgradient of drainage feature (M_DF_3)
 Soil Type (Muller, 2008) Kokotungo
 ALC (Thompson) Class A
 Soil Condition Texture contrast soils, sodic subsoil and shallow topsoil.

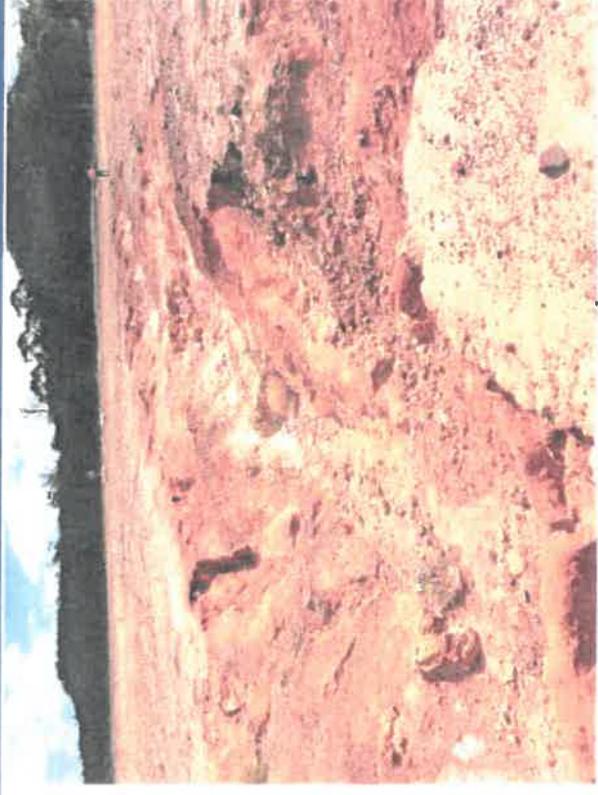
M_Gully_9	Type of erosion feature	Gully
	Lease Area	B2
	Landform	Simple slope
	Location	East of cattleyard2
	Soil Type (Muller, 2008)	Kokotungo
	ALC (Thompson)	Class A
	Soil Condition	Texture contrast soils, sodic subsoil and shallow topsoil.

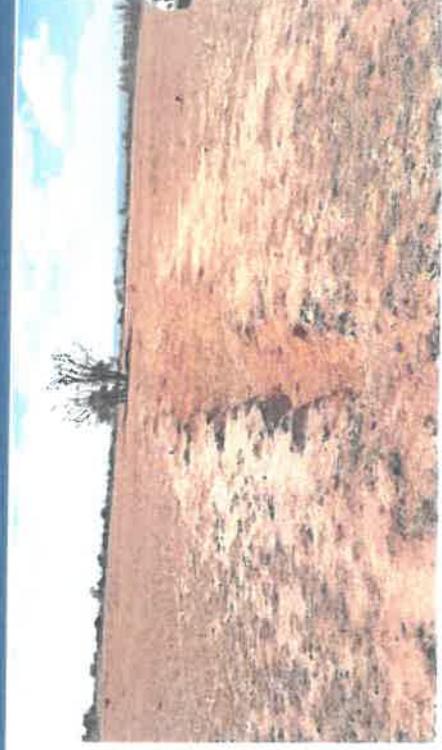
Top of feature coordinate Latitude: -24.061241
 Longitude: 150.423583
Maximum depth (m) 0.5
Maximum width (m) 9
Length (m) 35
Description Contributing factors to the erosion included low groundcover, cattle traffic, shallow topsoil and sodic subsoils.

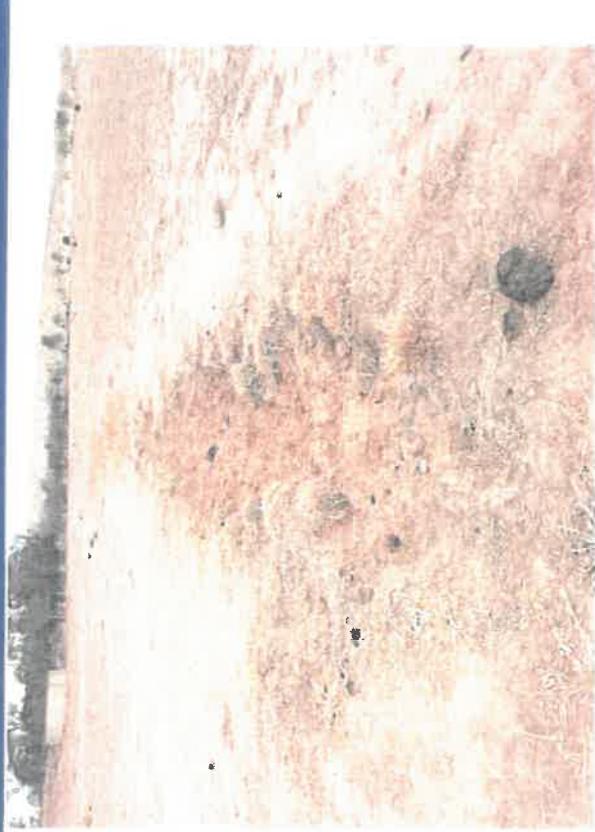
Description
 Contributing factors to the erosion included low groundcover and cattle traffic.

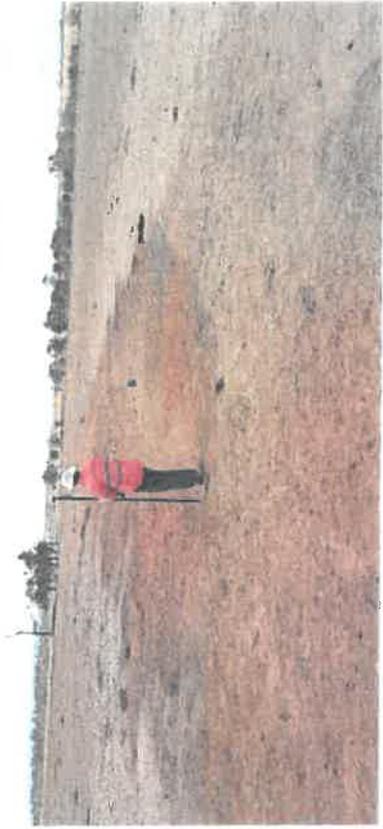
M_Gully_12 Type of erosion Gully
 feature
Lease Area B2
Landform Simple slope
Location Southern portion of lease area B2
Soil Type (Muller, 2008) Bluff
ALC (Thompson) Class C
Soil Condition Texture contrast soils, sodic subsoil and shallow topsoil.
Top of feature coordinate Latitude: -24.06644
 Longitude: 150.418547
Maximum depth (m) 0.6
Maximum width (m) 10

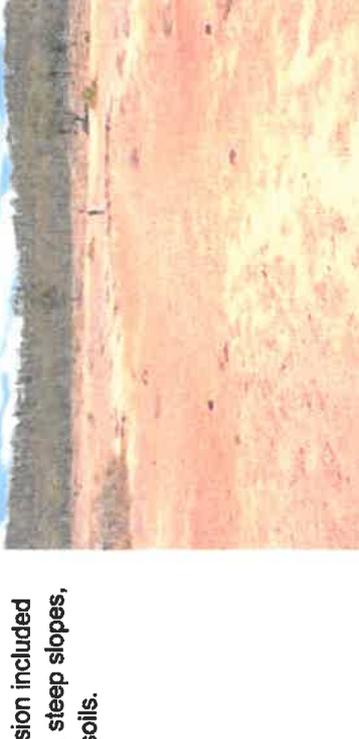
M_Gully_13	<p>Type of erosion feature</p> <p>Lease Area</p> <p>Landform</p> <p>Location</p> <p>Soil Type (Muller, 2008)</p> <p>ALC (Thompson)</p> <p>Soil Condition</p> <p>Top of feature coordinate</p>	<p>Gully</p> <p>B2</p> <p>Simple slope</p> <p>Southern portion of lease area B2</p> <p>Kokotungo</p> <p>Class A</p> <p>Texture contrast soils, sodic subsoil and shallow topsoil.</p> <p>Latitude: -24.065527</p> <p>Longitude: 150.42116</p>

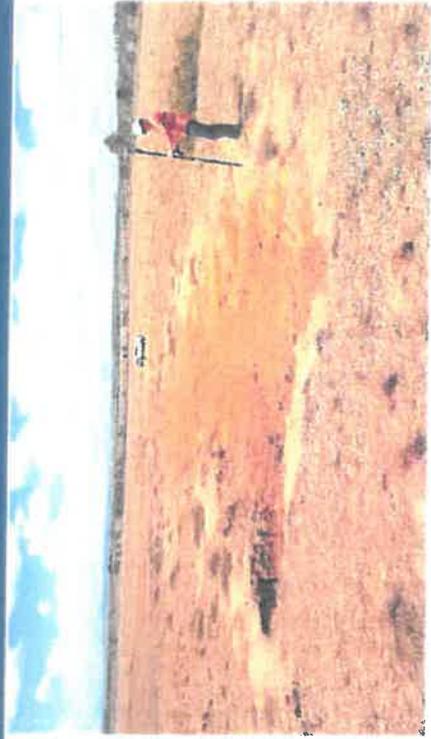
Maximum depth (m) 0.5
 Maximum width (m) 10
 Length (m) 110
 Description Contributing factors to the erosion included low groundcover, cattle traffic, steep slopes, shallow topsoil and sodic subsoils.

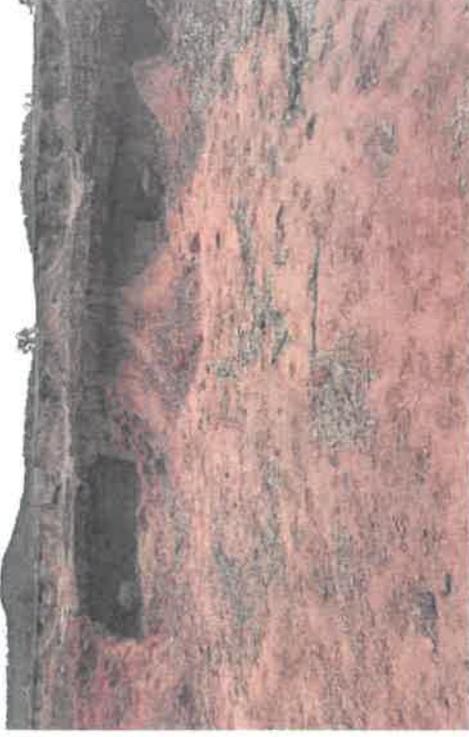
M_EF_2	Type of erosion feature	Minor gully
	Lease Area	B2
	Landform	Open depression
	Location	North east of Dam12
	Soil Type (Muller, 2008)	Kokotungo
	ALC (Thompson)	Class A
	Soil Condition	Texture contrast soils, sodic subsoil and shallow topsoil.
	Top of feature coordinate	Latitude: -24.059245 Longitude: 150.42395

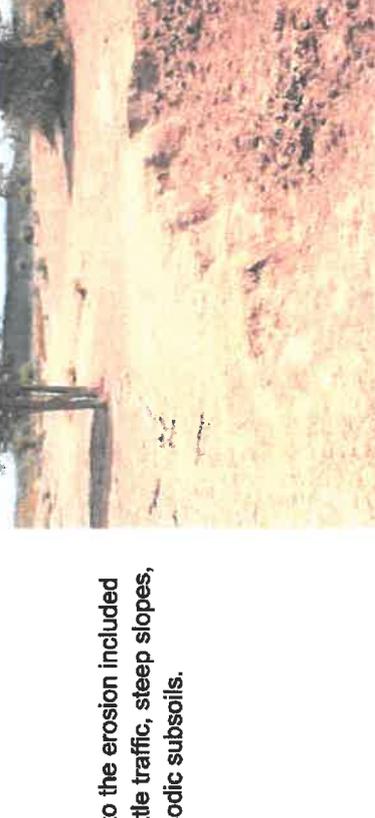
<p>Type of erosion feature Minor gulying along watercourse</p>	
	<p>Lease Area B2</p>	
	<p>Landform Watercourse and open depression.</p>	
	<p>Location Upgradient of Dam11</p>	
	<p>Soil Type (Muller, 2008) Kokotungo</p>	
	<p>ALC (Thompson) Class A</p>	
	<p>Soil Condition Texture contrast soils, sodic subsoil and shallow topsoil.</p>

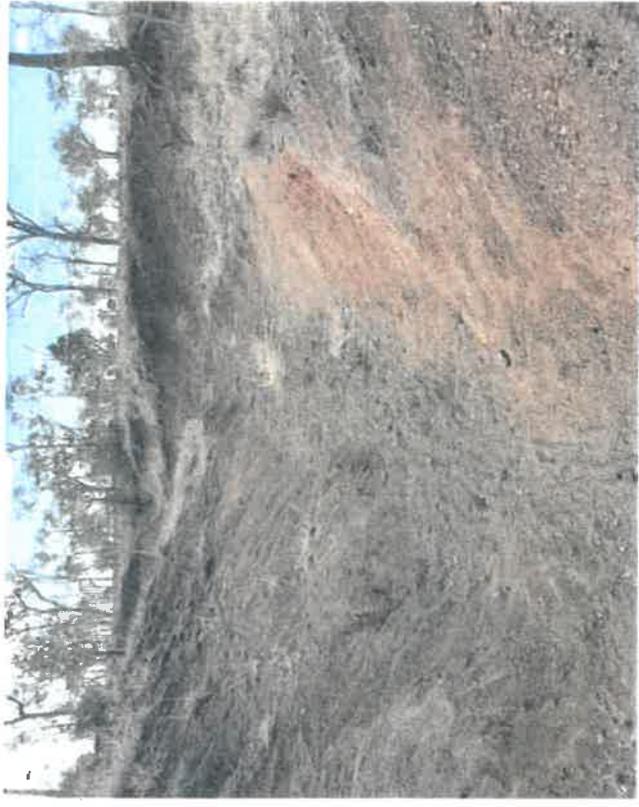
M_Gully_15	<p>Type of erosion feature</p> <p>Gully</p> <p>Lease Area</p> <p>B2</p> <p>Landform</p> <p>Open depression</p> <p>Location</p> <p>Upgradient of drainage feature (M_DF_4)</p>

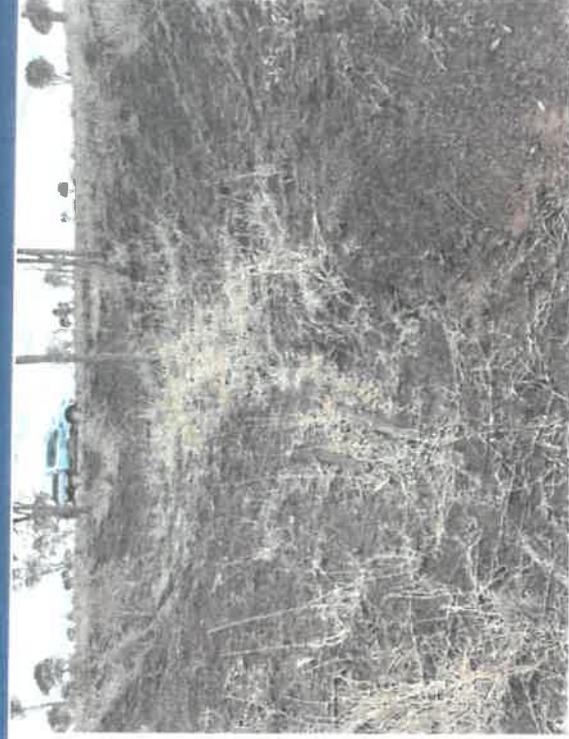
Soil Type (Muller, 2008) Clancy
 ALC (Thompson) Class A
 Soil Condition Cracking clay soils
 Top of feature coordinate Latitude: -24.060447
 Longitude: 150.439223
 Maximum depth (m) 2
 Maximum width (m) 6
 Length (m) 95
 Description Contributing factors to the erosion included steep slope, concentrated flow, low sidewall groundcover, contour banks and cattle traffic.

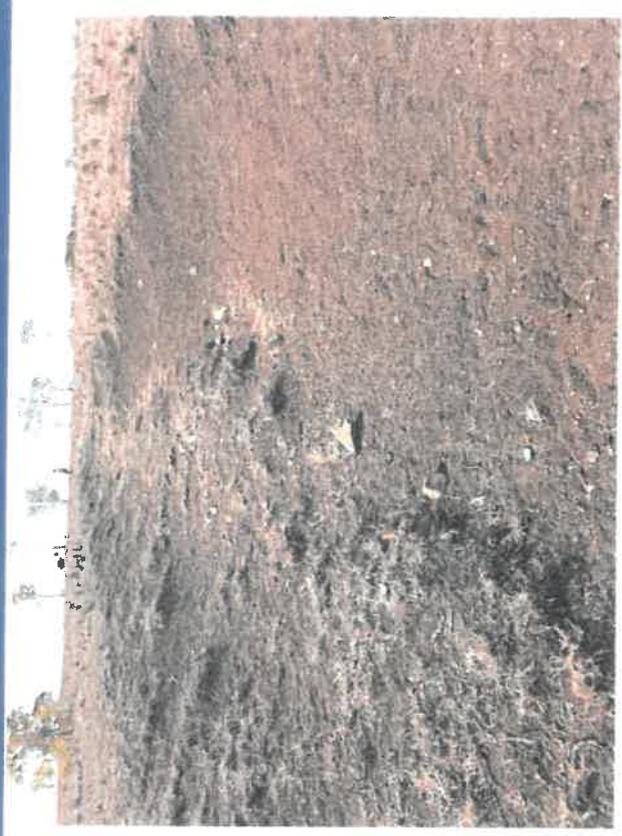
Maximum depth (m) 1
Maximum width (m) 7
Length (m) 75
Description Contributing factors to the erosion included steep slope, contour banks and cattle traffic.
