LAND CONDITION ASSESSMENT

Smoky Creek Solar Farm

Project Number: J000283
Status: Final
Date: 27/09/2019

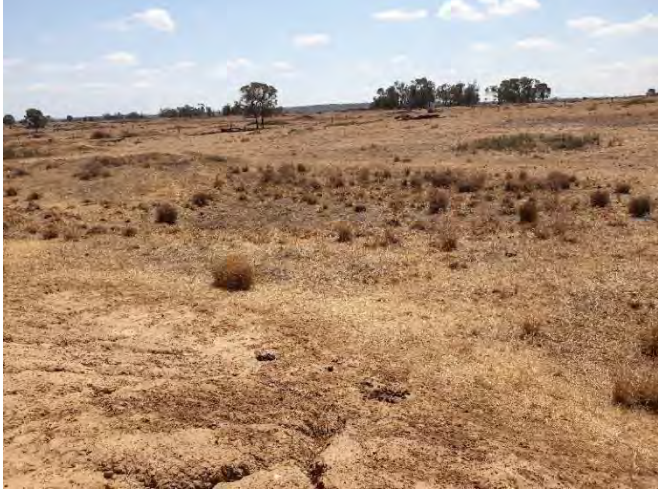
Constraint	Description	Soils	Representative Photograph
Gilgai microrelief (melonholes)	<ul style="list-style-type: none"> Gilgai are depressions that form in the surface of cracking clay soils (Vertosols). They can hold water during wet conditions. Continuous cultivation can level out some shallow gilgai. But they will reform if the ground is left undisturbed. Gilgai soil profiles include soils that are dispersive, very strongly acid and moderately saline. Melonhole gilgai were observed in the field to commonly be greater than 0.5 m deep and at least several metres wide. Soils that form gilgai occur across 20% of the lease areas 	Beldeen, Greycliffe and Greycliffe Melonhole Phase.

<p>View to the north of gilgai microrelief</p>

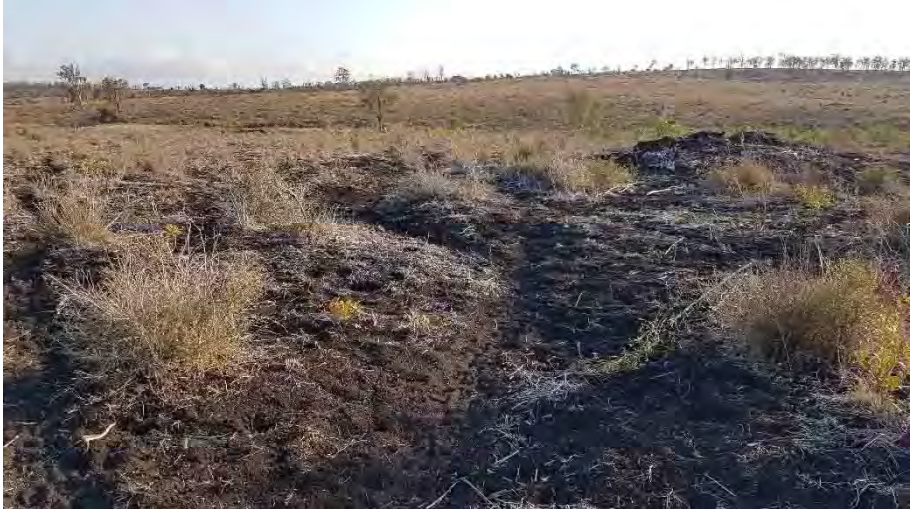
Constraint	Description	Soils	Representative Photograph
Shrink swell soils	<ul style="list-style-type: none"> Shrink-swell soils (or cracking clay soils) move or react to soil moisture. Infrastructure engineering designs need to account for soil movement by shrink-swell soils. Shrink swell soils occur across 39% of the lease areas. 	Annandale, Belldreen, Clancy, Earlsfield, Greycliffe and Greycliffe Melonhole Phase.

<p>Example of shrink swell (Vertosol) soils</p>

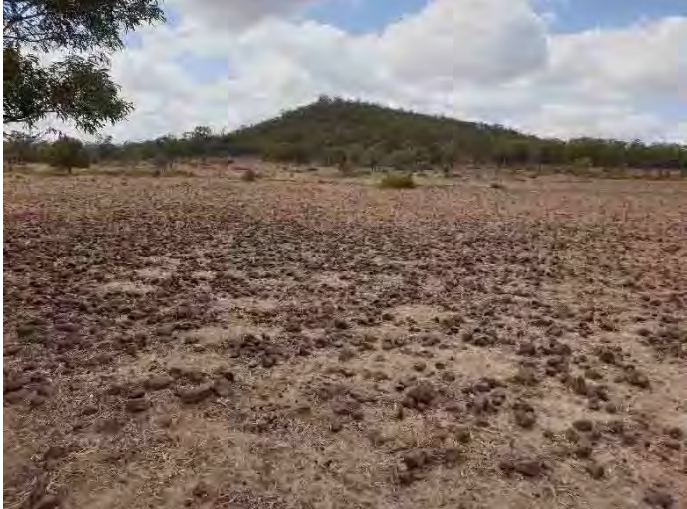
Constraint	Description	Soils	Representative Photograph
Surface rock	<ul style="list-style-type: none"> Dense surface rock was observed in parts of the lease areas. Rocks ranged in size from medium pebbles (6-20mm) to stones (60-200 mm). Surface rock can impede cultivation practices. 	Kokotungo, Spier, Ulogie and Annandale

<p>Example of dense surface rock cover.</p>

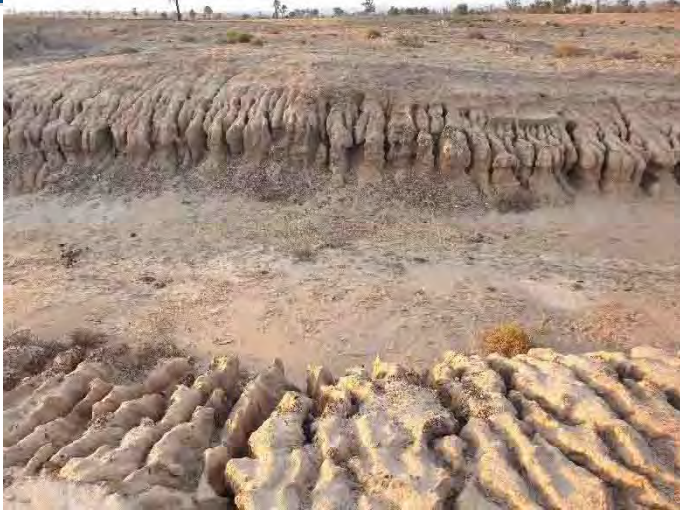
Constraint	Description	Soils	Representative Photograph
Dispersive soils	<ul style="list-style-type: none"> Dispersive soils include soils with an Exchangeable Sodium Percentage (ESP) of 15 or more or a Ca:Mg ratio <0.1. Dispersive soils present a high erosion risk if exposed. They also impede drainage and root growth. Topsoil (A horizon) is not normally dispersive soil. Dispersive soils commonly occur in the subsoil (B horizon). Dispersive soils at the site are mainly associated with gilgai soils (from 0.2 m) and texture contrast soils (from 0.2 m). Dispersive soils occur at 0.8 m for Earlsfield soils (Vertosols). Soils with dispersive soils in their profile occur across 75% of the lease areas. 	Bluff, Desdemona, Earlsfield, Greycliffe, Greycliffe Melonhole Phase, Kokotungo and Ulogie.

<p>Example of dispersive soil erosion.</p>
Very strongly acid soils	<ul style="list-style-type: none"> Very strongly acid soils have a pH <5. Very strongly acid soils can limit plant growth for agriculture or rehabilitation due to decreased nutrient availability and increased elemental toxicity. Very strongly acid soils at the site are mainly associated with gilgai soils (from 0.4 m) and acid texture contrast soils (Kurosols) (throughout the profile). Very strongly acid soils occur at depth (1.4 m) for the Spier soils. Soils with very strongly acid soils in their profile occur across 27% of the lease areas. 	Greycliffe, Greycliffe Melonhole Phase, Bluff and Spier.	Not available.

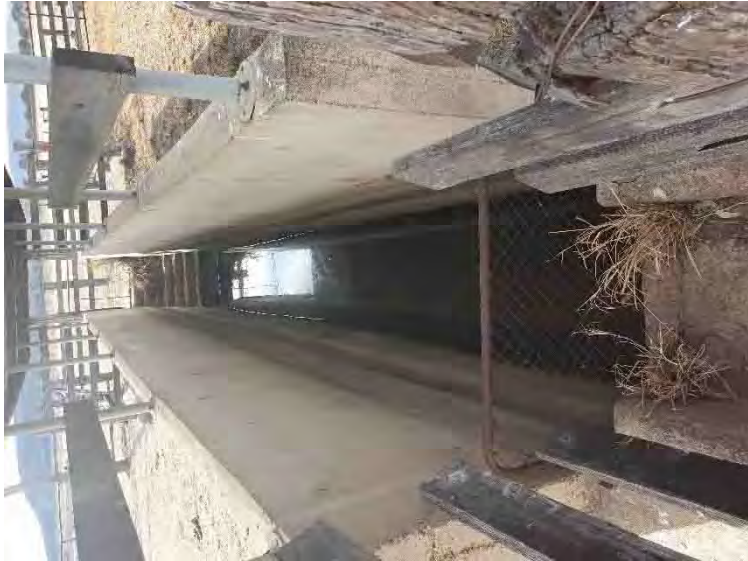
Constraint	Description	Soils	Representative Photograph
Contaminated soil	<ul style="list-style-type: none"> Cattle dips were located at Lease Areas A and E. Common soil contaminants at cattle dips include arsenic and DDT. Contamination at cattle dips is usually localised to the dip area (i.e. nominally within 30m of the dip and associated infrastructure⁵). 	Greycliffe and Kokotungo

<p>View to the east of a livestock plunge dip</p>

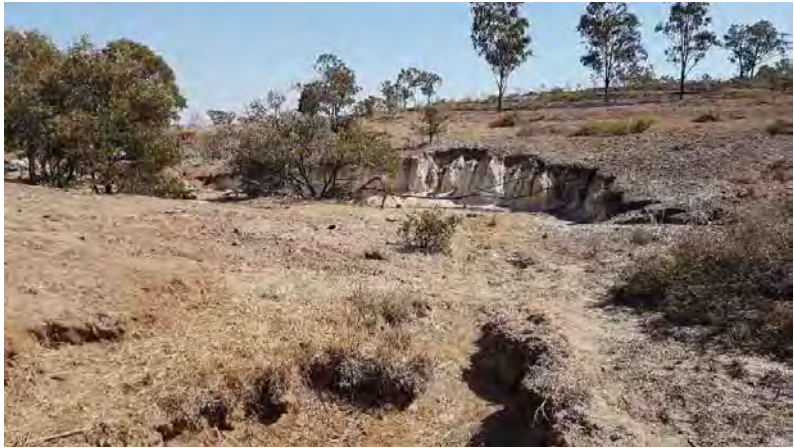
Constraint	Description	Soils	Representative Photograph
Steep slopes	<ul style="list-style-type: none"> Steeply sloping land exceeds 3%. Steeply sloping land occurs in lease areas A, B1, B2, D2 and G2 Steeply sloping land, particularly where dispersive soils occur, can increase the risk of erosion for land disturbing activities for agriculture or construction. 	<p>Annandale, Belldreen, Bluff, Clancy, Earlsfield, Greycliffe Melonhole Phase, Greycliffe, Kokotungo, Santo Fertile Phase, Santo Stony Phase, Spier, Ulogie</p>

<p>View to the north of steeply sloping land.</p>

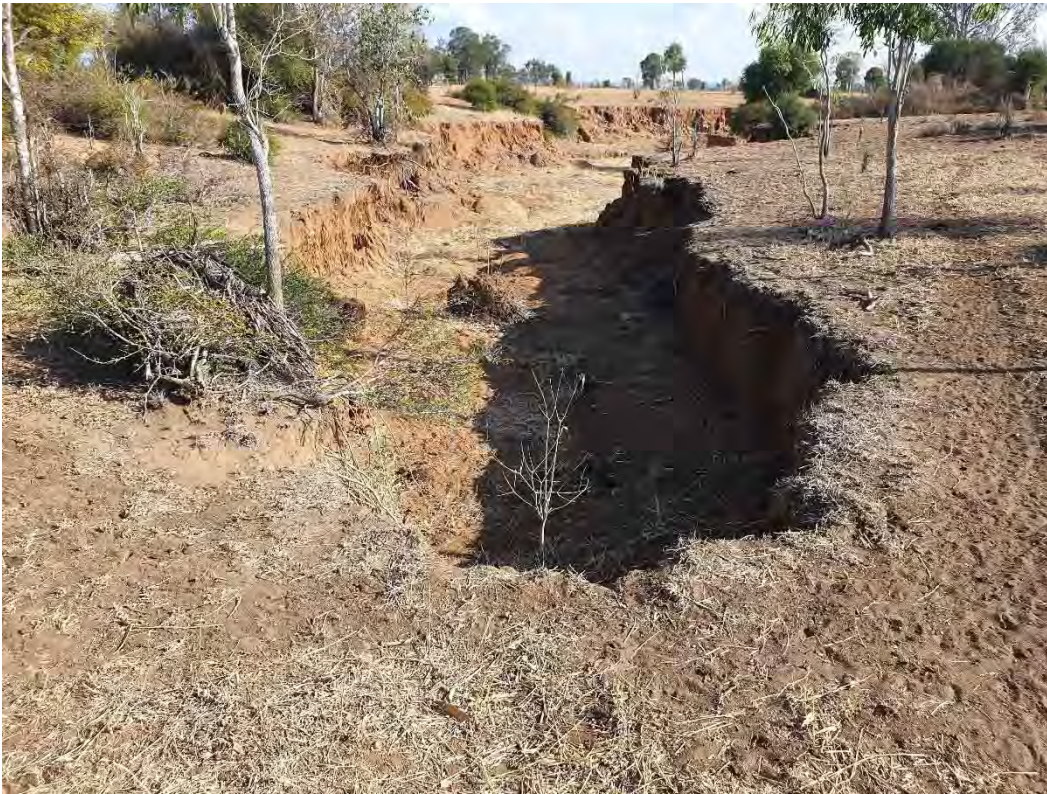
Photograph 1 View to the west of a gully head with limited adjoining groundcover

- Exclusion of established erosion features, including an adequate buffer area. Fences can be installed to establish exclusion areas. Exclusion areas prevent further physical disturbance (including grazing by native fauna) and assists in the rehabilitation (including groundcover) of erosion features.

- Reshaping or filling a gully may be considered if stabilisation (including amelioration and revegetation) is unsuccessful, impractical or if reclamation of land is beneficial to the development. Reshaping and filling works are not recommended in watercourses.

- Shaping of the gully walls should be carried out only after the head of the gully has been stabilised.

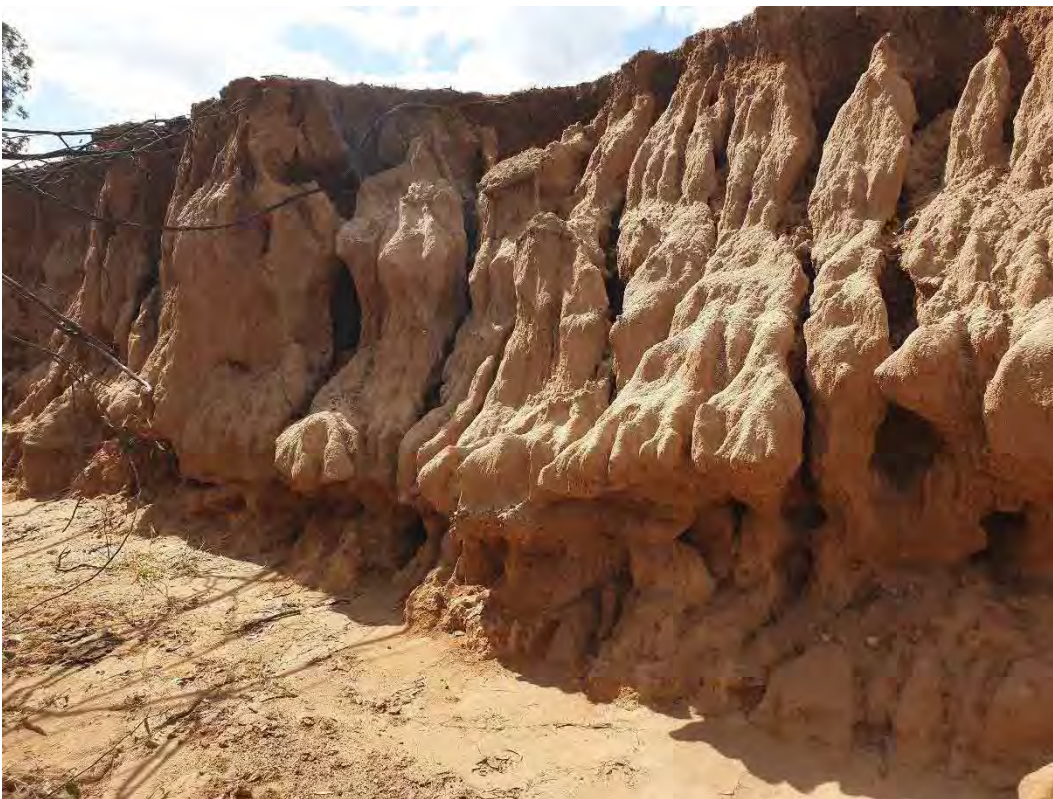
Photograph 2 View to the north of a gully sidewall in dispersive soils

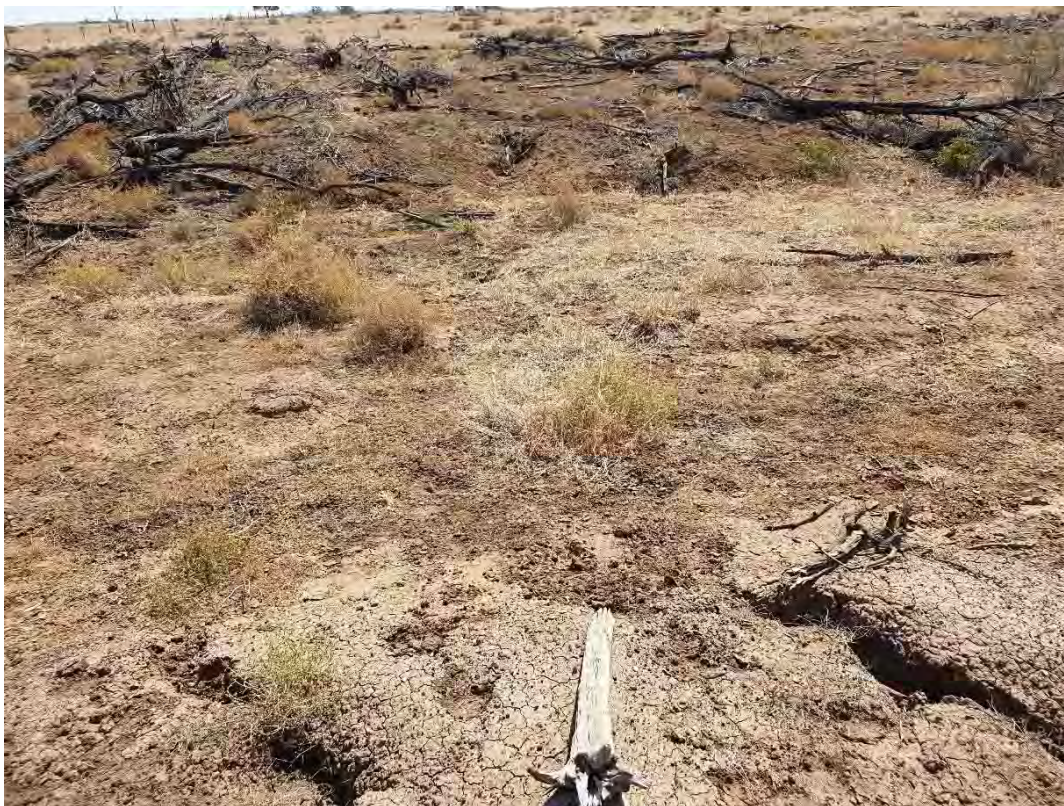
Photograph 4 View to the north of cleared trees along a drainage line

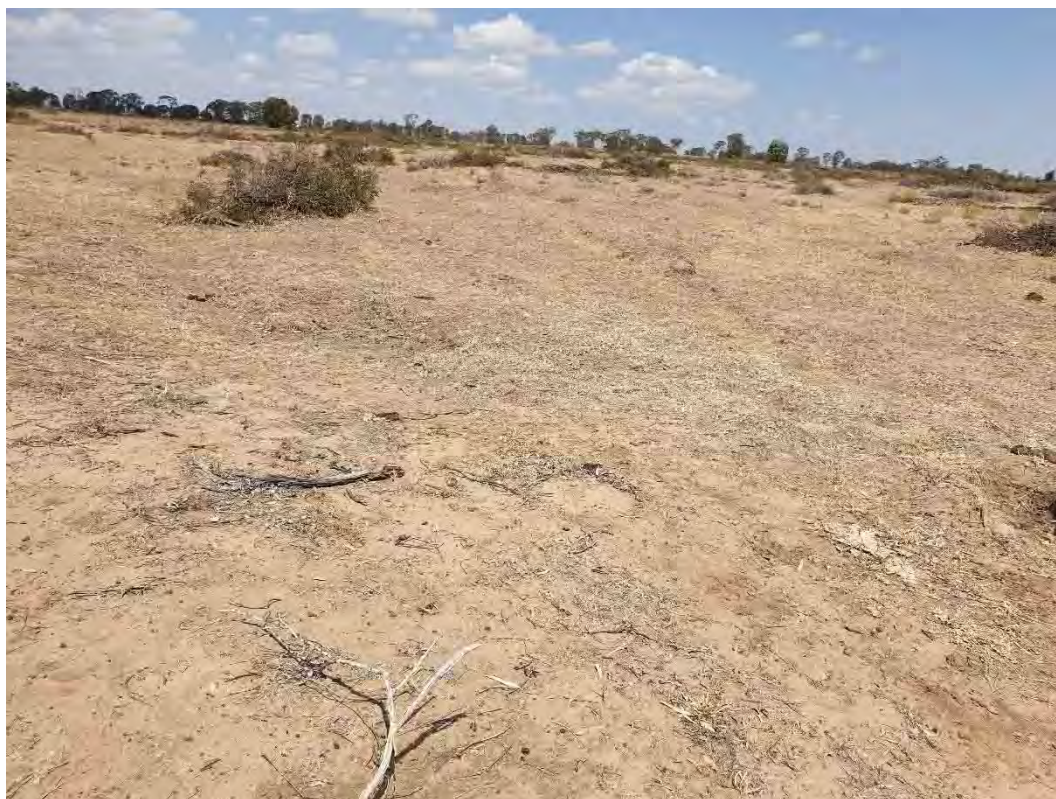
Photograph 5 View to the south of low groundcover due to drought conditions

- Promote rehabilitation and revegetation of natural drainage features where practicable. Direct sowing of grass species at upgradient areas may be required.
- Surface cover is the key mitigating factor to the formation of erosion, including gully erosion. Surface cover reduces the risk of erosion by stabilising soils, improves rainfall infiltration and dissipates rainfall.
- Retaining or re-establishing trees will assist in lowering the water table, drying out the soil profile and stabilising subsoils. This may only be practical in exclusion and riparian areas not subject to development and where shading will not impact solar panel performance.
- Erosion control mats can be considered as they may assist with seed germination and provide protection from raindrop impact erosion. The mats are not intended for use in high-flow velocity areas.
