LAND CONDITION ASSESSMENT

Smoky Creek Solar Farm

Appendix B

Project Number: J000283
Status: Final
Date: 27/09/2019

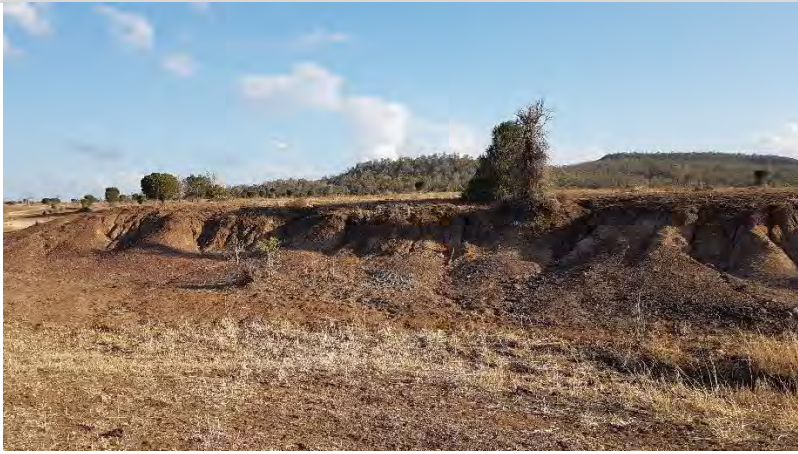
D_DF_1	Type of erosion feature	Erosion of bank of watercourse	
	Lease Area	E

Landform	Watercourse	
	Location	Banks	
	Soil Type (Muller, 2008)	Earlsfield & Annandale	
	ALC (Thompson)	Class A	
	Soil Condition:	Cracking clay soils	
	Start of feature coordinate	Latitude: -24.048862 Longitude: 150.415501	
	Maximum depth (m)	1.5	
	Maximum width (m)	8	
	Length (m)	935	
	Description	Contributing factors to the erosion of some banks of the watercourse

Erosion feature I.D	Description		Photograph
		include unstable ground surface conditions and sidewalls (low groundcover). Evidence of lateral bank erosion at some locations.	
D_EF_7	Type of erosion feature	Extensive erosion

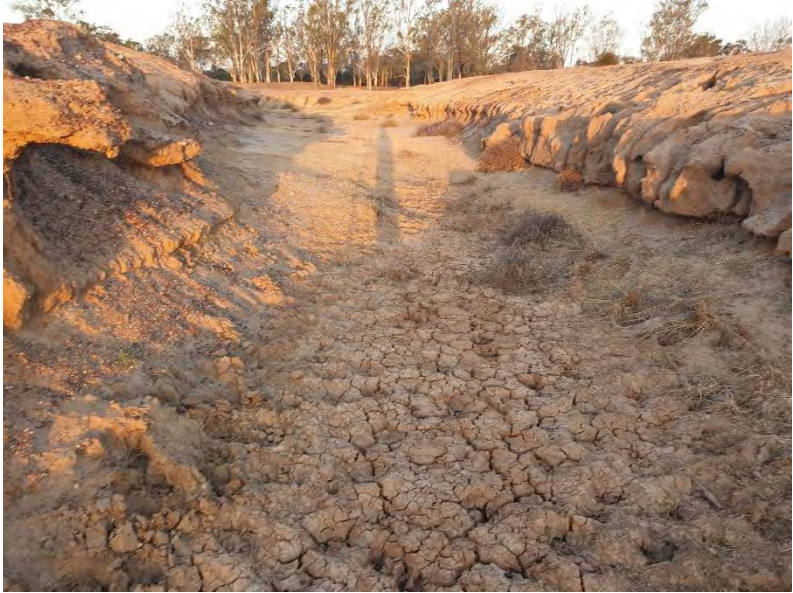
Lease Area	F	
	Landform	Watercourse and lower slope	
	Location	North of Dodson Road surrounding Dam9	
	Soil Type (Muller, 2008)	Kokotungo	
	ALC (Thompson)	ALC A	
	Soil Condition:	Texture contrast soils, sodic subsoil and shallow topsoil.	
	Start of feature coordinate	Latitude: -24.05323 Longitude: 150.424797 Note: Start of feature at Dodson Road	
	Maximum depth (m)	2.5	
	Maximum width (m)	280	
	Length (m)	290	
	Description	Contributing causes include concentrated flow from upgradient watercourses and dams, groundcover and dispersive subsoils.	
D_DF_3	Type of erosion feature	Gully & watercourse	
	Lease Area	E & F

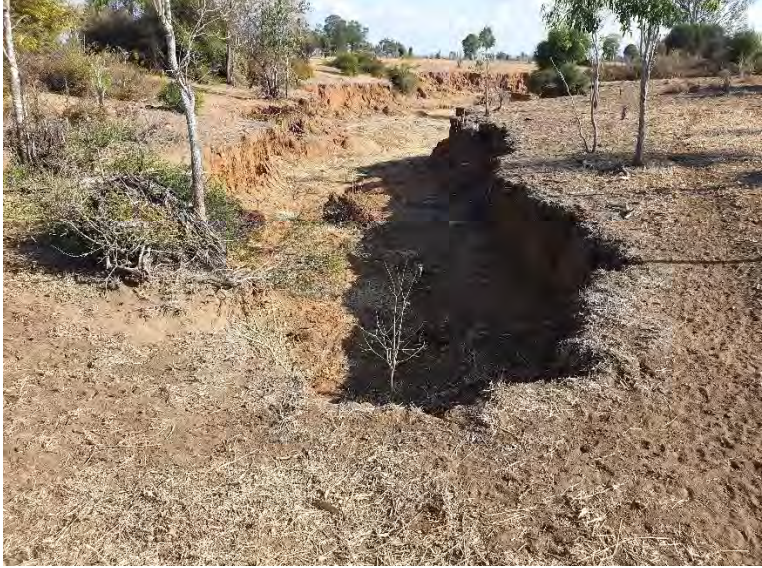
Location	Downgradient of Dam9	
	Soil Type (Muller, 2008)	Kokotungo	
	ALC (Thompson)	ALC A	
	Soil Condition:	Texture contrast soils, sodic subsoil and shallow topsoil.	
	Head of gully coordinate	Latitude: -24.0484 Longitude: 150.425296	
	Maximum depth (m)	Range from <0.5->2	
	Maximum width (m)	50	
	Length (km)	1.56	
	Description	Contributing causes include concentrated flow from upgradient watercourses and dams, groundcover and dispersive subsoils. Unstable sidewalls and limited upgradient groundcover. Evidence of lateral bank erosion at some locations.	
D_DF_6	Type of erosion feature	Erosion of banks of watercourse & rill	
	Lease Area	G2	
	Landform	Watercourse & lower slope	
	Location	Gully erosion formed at upgradient property east of the site and extended onto the site.	
	Soil Type (Muller, 2008)	Clancy

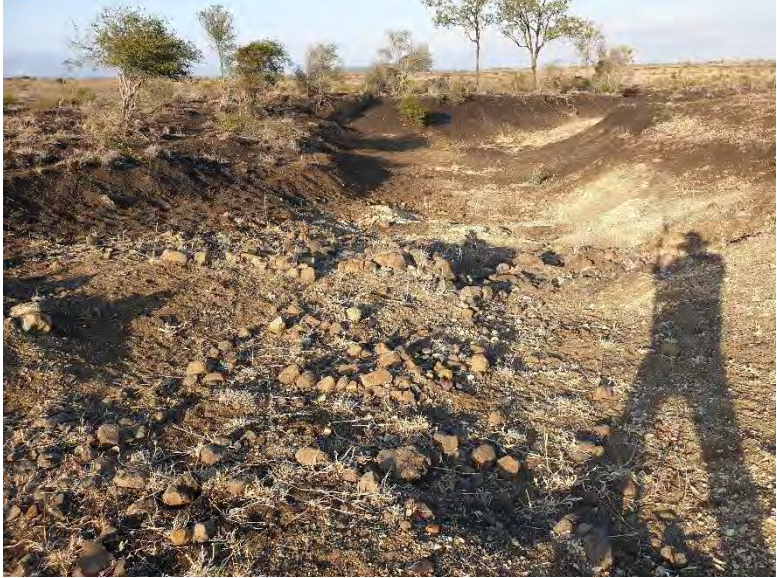
Soil Condition:	Cracking clay soils	
	Top of feature coordinate	Latitude: -24.043093 Longitude: 150.437625	
	Maximum depth (m)	1	
	Maximum width (m)	8	
	Length (m)	230	
	Description	Contributing factors to the erosion of some banks of the watercourse include low groundcover and cattle traffic.	
D_Gully_3	Type of erosion feature	Gully	
	Lease Area	G2	
	Landform	Watercourse & lower slope	
	Location	Gully erosion formed at downgradient extent of Dam10	
	Soil Type (Muller, 2008)	Clancy	
	ALC (Thompson)	Class A	
	Soil Condition:	Cracking clay soils	
	Gully head coordinate	Latitude: -24.04213 Longitude: 150.43515	
	Maximum gully depth (m)	1.5	
	Maximum width (m)	10

Description	Contributing factors to the erosion include low groundcover, concentrated flow from the dam and cattle traffic.	
D_DF_4	Type of erosion feature	Erosion of banks of watercourse	
	Lease Area	G2	
	Landform	Watercourse, upper to lower slopes	
	Location	Gully erosion formed at upgradient property north of the site and extended onto the site.	
	Soil Type (Muller, 2008)	Santo	
	ALC (Thompson)	Class C	
	Soil Condition:	Friable non-cracking clay or clay loam soils	
	Start of feature coordinate	Latitude: -24.038453 Longitude: 150.435185

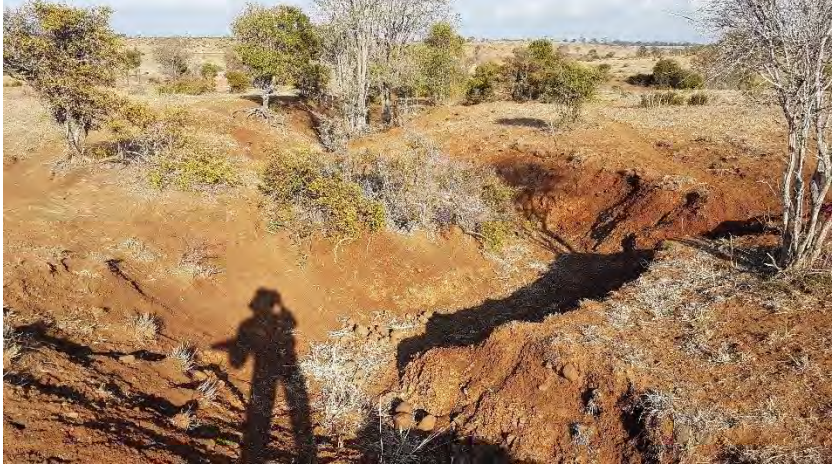
Maximum width (m)	14	
	Length (m)	450	
	Description	Contributing factors to the erosion included low groundcover and steep slope. Unstable sidewalls and limited upgradient groundcover.	
D_EF_5	Type of erosion feature	Gully	
	Lease Area	G2	
	Landform	Upper slopes and crest	
	Location	Lateral bank erosion from watercourse.	
	Soil Type (Muller, 2008)	Santo	
	ALC (Thompson)	Class C	
	Soil Condition:	Friable non-cracking clay or clay loam soils	
	Head of gully coordinate	Latitude: -24.038453 Longitude: 150.435185	
	Maximum depth (m)	3	
	Maximum width (m)	20	
	Length (m)	140

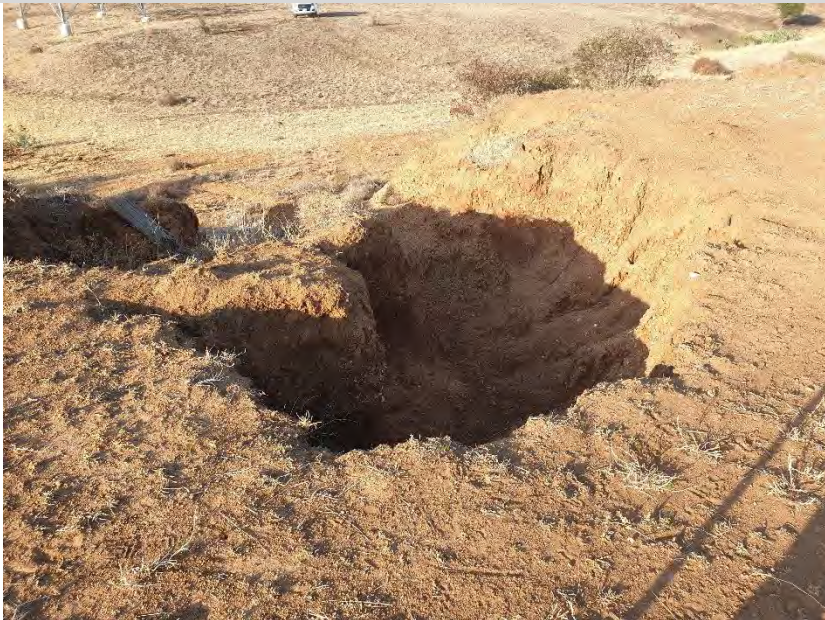
Erosion feature I.D	Description	Photograph
	<p>Description</p> <p>Contributing factors to the erosion included low groundcover, steep slope and sodic subsoils. Unstable sidewalls and limited upgradient groundcover.</p>

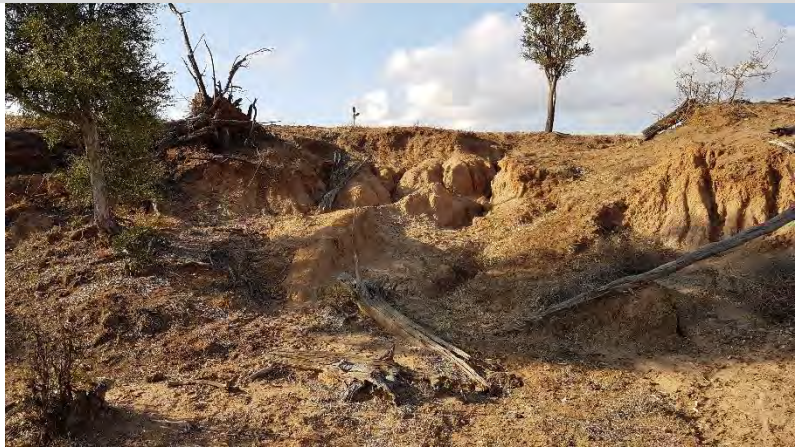
D_DF_2	Type of erosion feature	Erosion of banks of watercourse
	Lease Area	G2
	Landform	Watercourse and lower slopes.
	Location	Erosion formed from watercourse originating upgradient property north of the site and extended onto the site.
	Soil Type (Muller, 2008)	Kokotungo
	ALC (Thompson)	ALC A
	Soil Condition:	Texture contrast soils, sodic subsoil and shallow topsoil.

Erosion feature I.D	Description	Photograph
	Top of feature coordinate	Latitude: -24.036238 Longitude: 150.421
	Maximum depth (m)	3
	Maximum width (m)	16
	Length (m)	450
	Description	Contributing factors to the erosion included low groundcover, steep slope and sodic subsoils. Unstable sidewalls and limited upgradient groundcover.

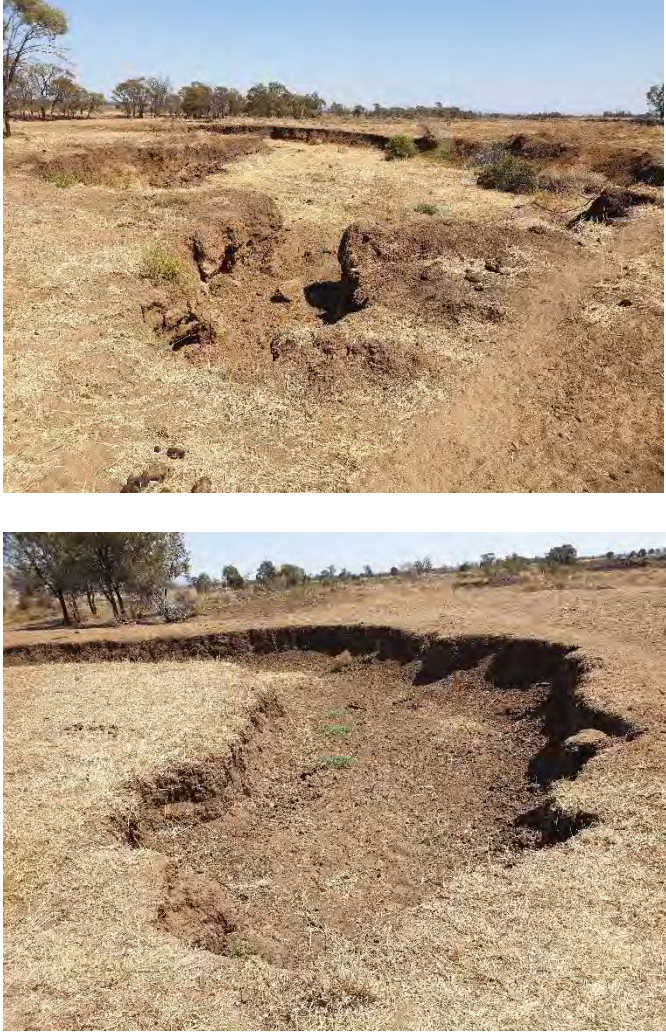
Maximum width (m)	14	
	Length (m)	2.1 km	
	Description	<p>Contributing factors to the erosion included low groundcover, concentrated flow from dams, including upgradient, cattle traffic and sodic subsoils at some locations.</p> <p>Unstable head and sidewalls and limited upgradient groundcover.</p>

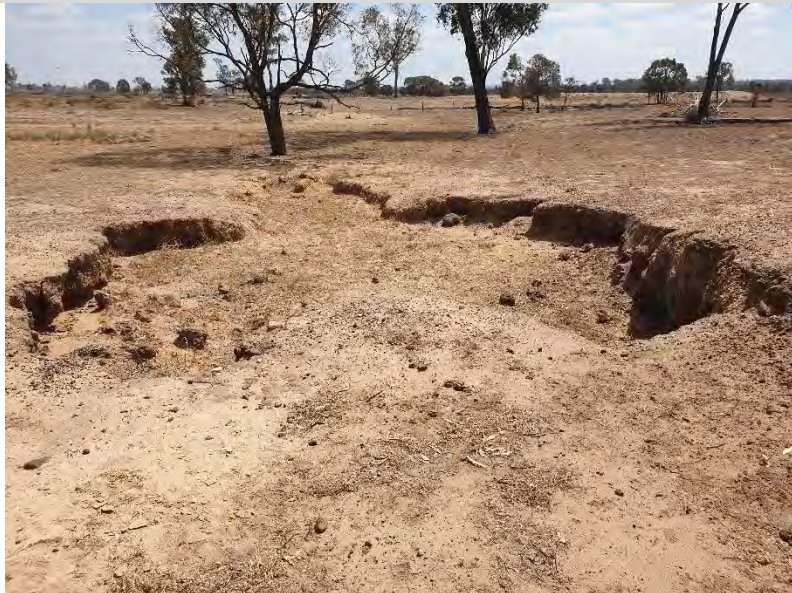
Erosion feature I.D	Description		Photograph
	Description	Contributing factors to the erosion included low groundcover and cattle traffic. Unstable head and sidewalls and limited upgradient groundcover.

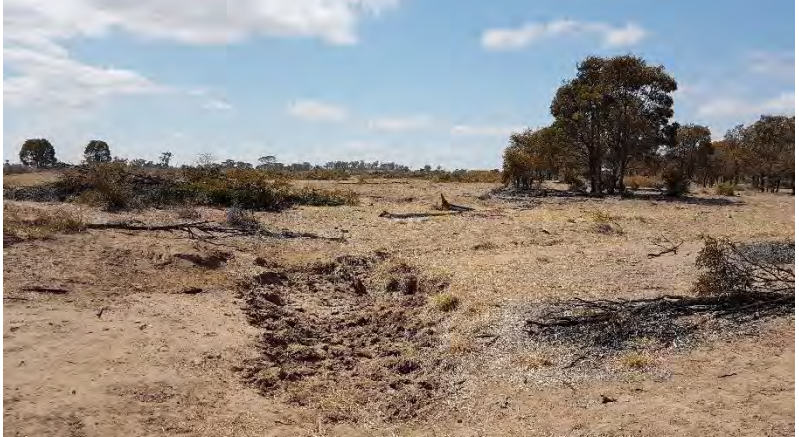
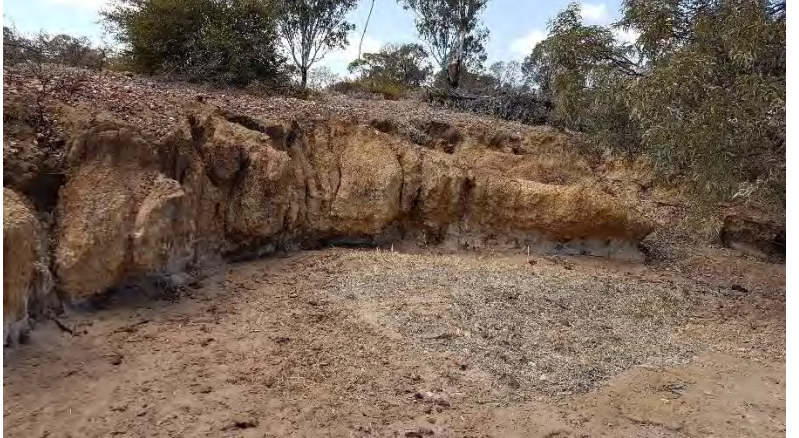
F_DF_2	Type of erosion feature	Erosion of banks of watercourse and lateral bank erosion and gullies	
	Lease Area	D2	
	Landform	Watercourse and lower slopes.	
	Location	Watercourse from the western portion of the property	
	Soil Type (Muller, 2008)	Kokotungo	
	ALC (Thompson)	ALC C	
	Soil Condition:	Texture contrast soils, sodic subsoil and shallow topsoil.	
	Top of feature coordinate	Latitude: -24.026443 Longitude: 150.390647

Maximum width (m)	2	
	Length (m)	80	
	Description	Contributing factors to the erosion included low groundcover, sodic subsoils and cattle tracking.	
F_DF_1	Type of erosion feature	Erosion of banks of watercourse and lateral bank erosion

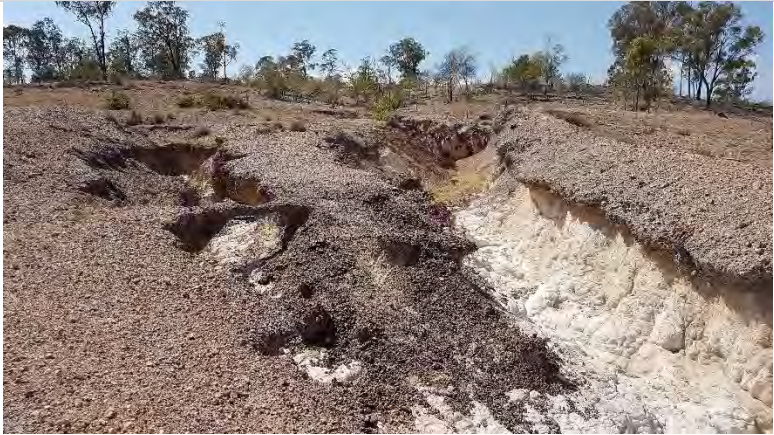
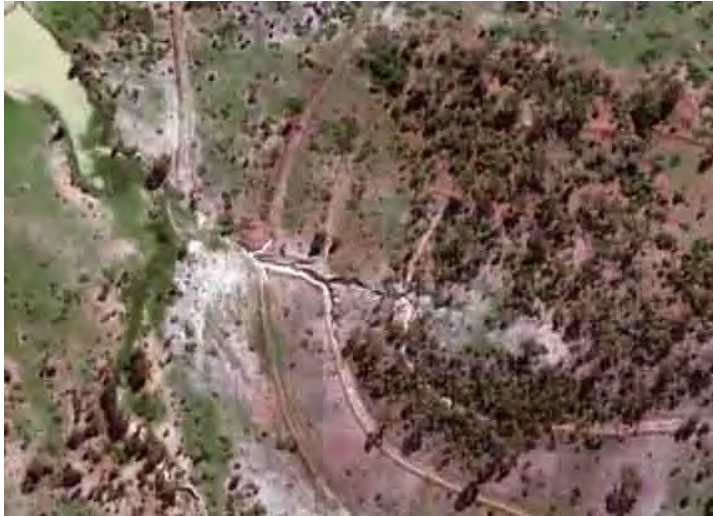
Lease Area	D1 & D2	
	Landform	Watercourse and lower slopes.	
	Location	Erosion formed from watercourse originating upgradient property to the east across Dodsons Road.	
	Soil Type (Muller, 2008)	Kokotungo	
	ALC (Thompson)	ALC C	
	Soil Condition:	Texture contrast soils, sodic subsoil and shallow topsoil.	
	Top of feature coordinate	Latitude: --24.030501 Longitude: 150.402416 Head of secondary watercourse Latitude: --24.033482 Longitude: 150.399922

Maximum width (m)	5-15	
	Length (km)	1.8	
	Description	Contributing factors to the erosion included low groundcover, cattle tracking and sodic subsoils. Unstable head and sidewalls (including of banks) and limited upgradient groundcover.	
	Type of erosion feature	Gully	
	Lease Area	D2	
	Landform	Upper slope	
	Location	East of Dodsons Road	
	Soil Type (Muller, 2008)	Kokotungo	
	ALC (Thompson)	ALC C	
	Soil Condition:	Texture contrast soils, sodic subsoil and shallow topsoil.	
	Gully head coordinate	Latitude: --24.028504 Longitude: 150.401092	
	Maximum depth (m)	1.2	
	Maximum width (m)	3	
	Length (m)	175	
	Description	Contributing factors to the erosion included contour banks and sodic subsoils. Unstable head and sidewalls (including of banks) and limited upgradient groundcover. Secondary gullies formed.

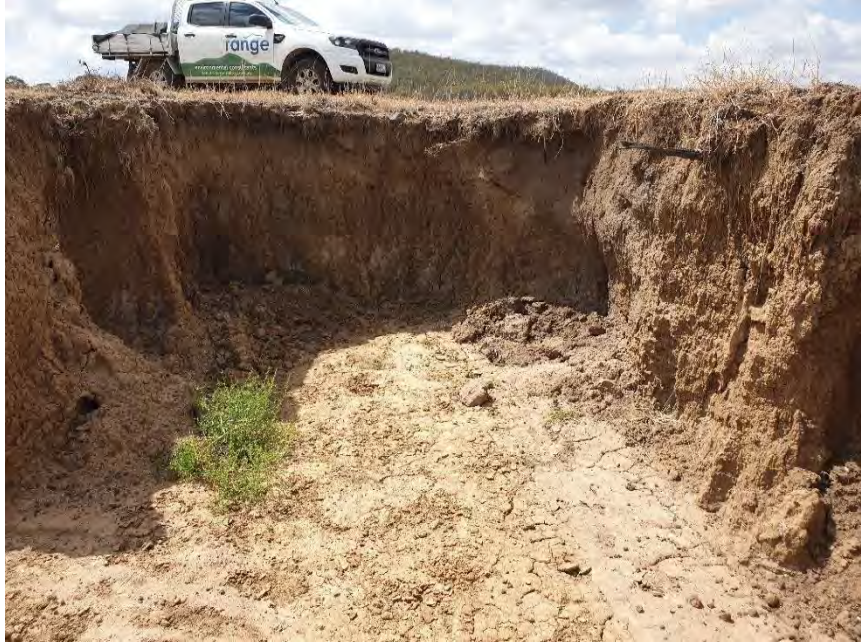
Gully head coordinate	Latitude: -24.06052 Longitude: 150.387346	
	Maximum depth (m)	1.5	
	Maximum width (m)	18	
	Length (m)	460	
	Description	<p>Contributing factors to the erosion included contour banks and sodic subsoils.</p> <p>Unstable head and sidewalls (including of banks) and limited upgradient groundcover.</p> <p>Secondary gullies formed along contour banks.</p> <p>Gully includes several secondary heads.</p>

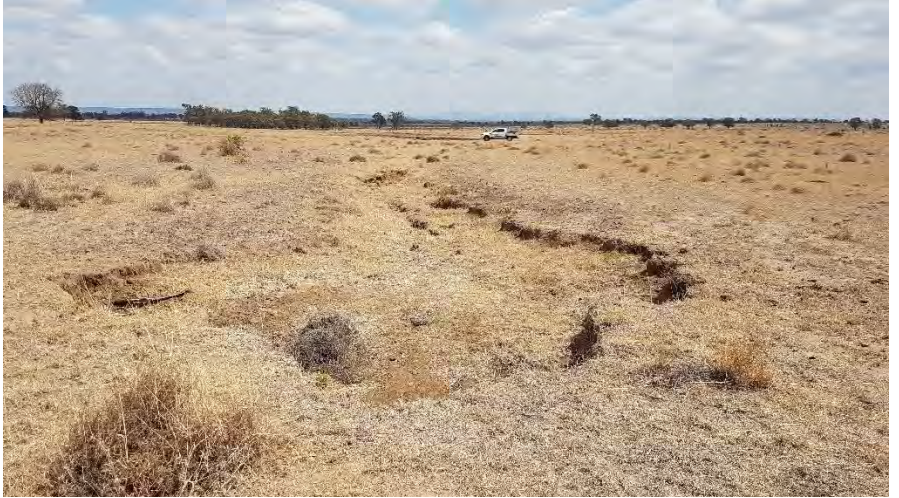
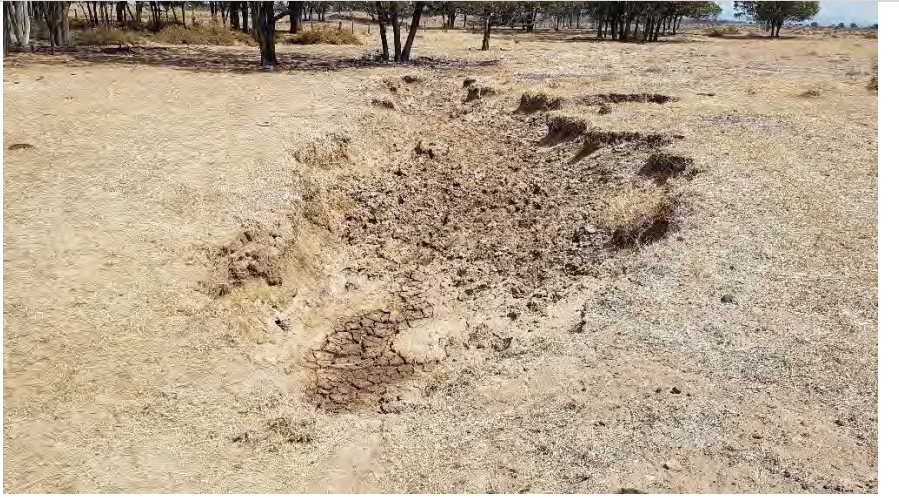
Maximum depth (m)	0.5	
	Maximum width (m)	8	
	Length (m)	80	
	Description	Contributing factors to the erosion included contour banks and sodic subsoils.	
M_Gully_4	Type of erosion feature	Gully

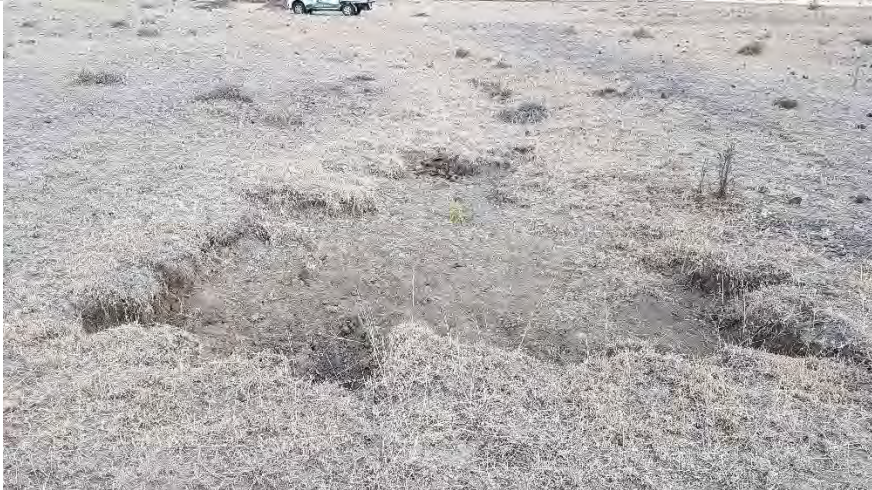
Description	Contributing factors to the erosion included contour banks and sodic subsoils. Unstable head and sidewalls (including of banks) and limited upgradient groundcover.	
	Type of erosion feature	Gully	
	Lease Area	A	
	Landform	Plain	
	Location	Upgradient of Dam18	
	Soil Type (Muller, 2008)	Kokotungo	
	ALC (Thompson)	Class A	
	Soil Condition	Texture contrast soils, sodic subsoil and shallow topsoil.	
	Gully head coordinate	Latitude: -24.059343 Longitude: 150.380686	
	Maximum depth (m)	0.5	
	Maximum width (m)	5	
	Length (m)	20	
	Description	Contributing factors to the erosion included contour banks and sodic subsoils. Unstable head and sidewalls (including of banks) and limited upgradient groundcover.	
M_Gully_6	Type of erosion feature	Gully	
	Lease Area	A	
	Landform	Simple slope

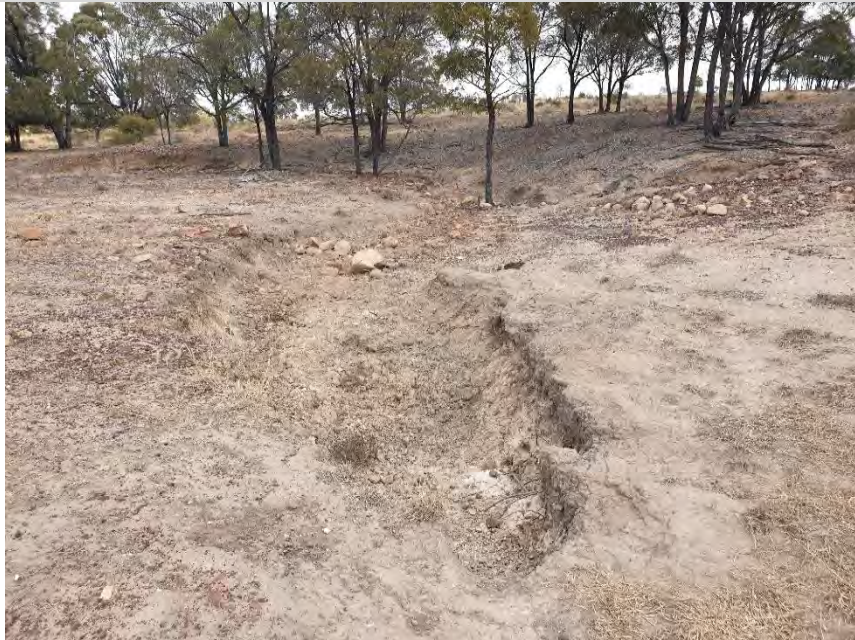
Maximum depth (m)	0.5	
	Maximum width (m)	5	
	Length (m)	48	
	Description	Contributing factors to the erosion included low groundcover, steep slope and sodic subsoils.	
M_Sheet_2	Type of erosion feature	Sheet erosion	
	Lease Area	A	
	Landform	Crest	
	Location	Upgradient of Dam14	
	Soil Type (Muller, 2008)	Spier & Kokotungo	
	ALC (Thompson)	Class A	
	Soil Condition	Texture contrast soils, sodic subsoil and shallow topsoil.

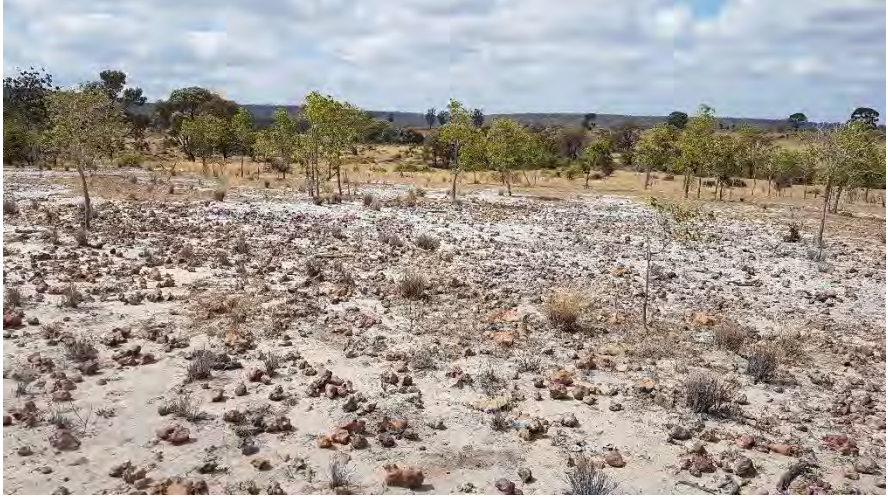
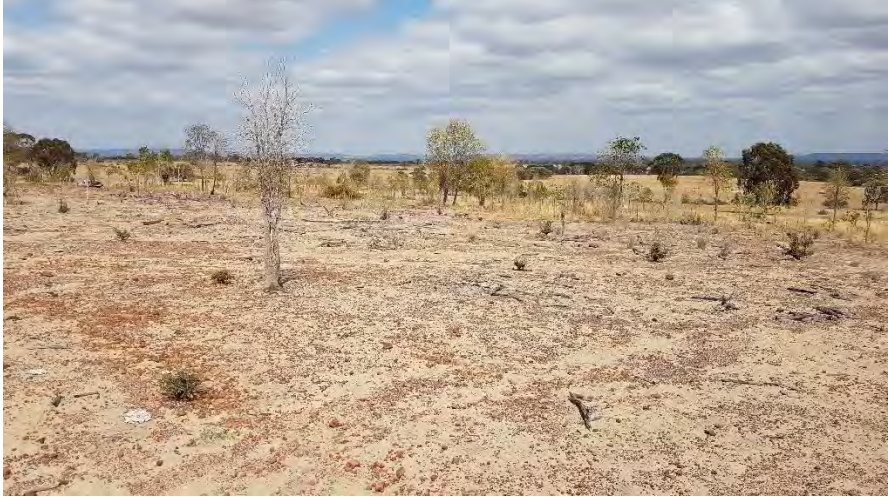
Maximum depth (m)	NA	
	Maximum width (m)	110 (north to south)	
	Length (m)	190 (east to west)	
	Description	Contributing factors to the sheet erosion include unstable ground surface condition, low groundcover and cattle tracking.	
M_Sheet_3	Type of erosion feature	Sheet

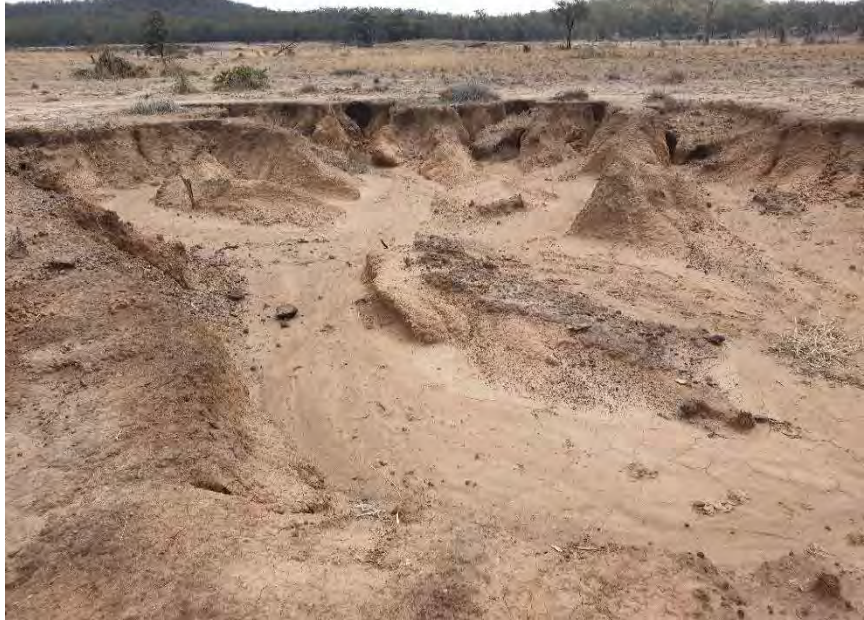
Length (m)	290 (north to south)	
	Description	Contributing factors to the sheet erosion include unstable ground surface condition, low groundcover and cattle tracking.	
	Type of erosion feature	Erosion of banks of watercourse and lateral bank erosion and gullies.	
	Lease Area	A	
	Landform	Watercourse	
	Location	Erosion of banks of watercourse	
	Soil Type (Muller, 2008)	Spier & Kokotungo	
	ALC (Thompson)	Class A	
	Soil Condition	Texture contrast soils, sodic subsoil and shallow topsoil.	
	Start of feature coordinate	Latitude: -24.068399 Longitude: 150.392243 Note: start of feature at eastern lease boundary	
	Maximum depth (m)	6	
	Maximum width (m)	90	
	Length (km)	1.8	
	Description	Contributing factors to the erosion included low groundcover, concentrated flow, cattle traffic, shallow topsoil and sodic subsoils. Unstable head and sidewalls and limited upgradient groundcover causing lateral bank erosion.

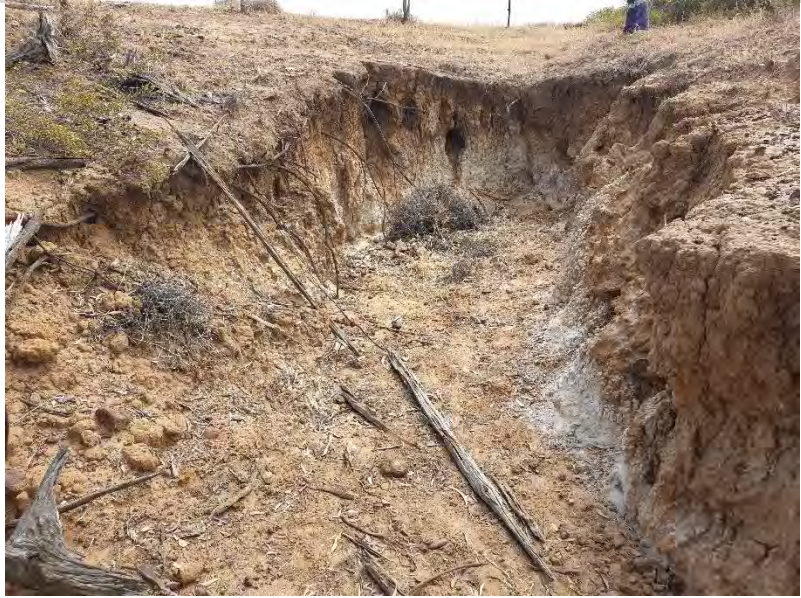
Erosion feature I.D	Description	Photograph
	Significant gully erosion adjoining dam.

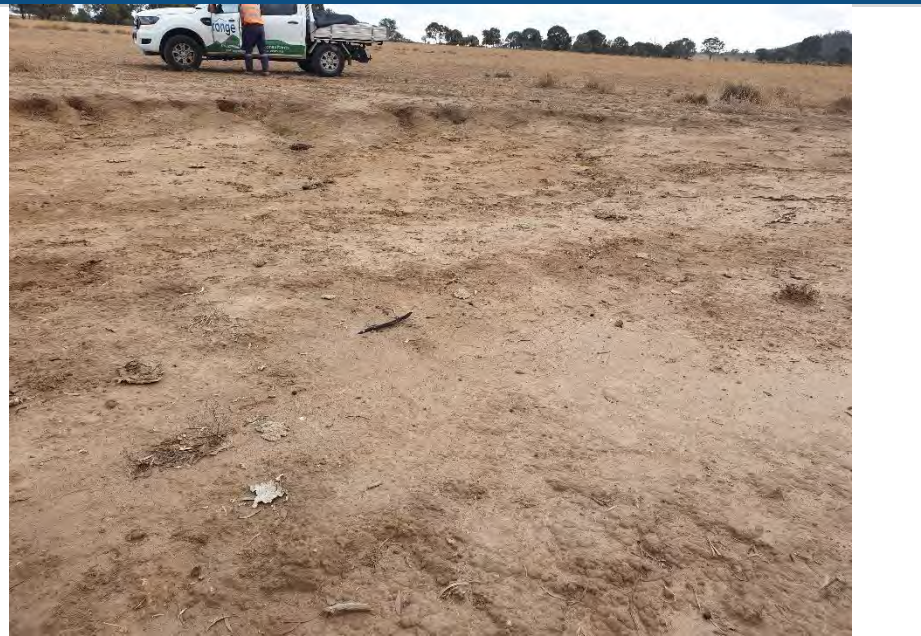
Maximum depth (m)	NA	
	Maximum width (m)	65	
	Length (m)	395	
	Description	Contributing factors to the erosion included low groundcover, cattle traffic, shallow topsoil and sodic subsoils.	
M_Gully_7	Type of erosion feature	Gully	
	Lease Area	B1 & B2	
	Landform	Simple slope	
	Location	South of Dodson's Road	
	Soil Type (Muller, 2008)	Earlsfield	
	ALC (Thompson)	Class A	
	Soil Condition	Friable non-cracking clay or clay loam soils	
	Top of gully coordinate	Latitude: -24.052188 Longitude: 150.411517

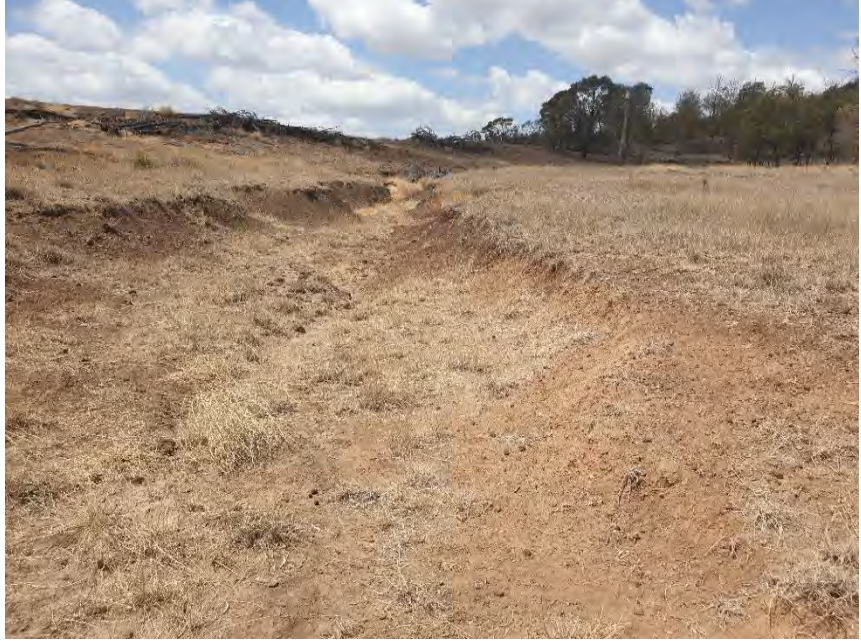
Erosion feature I.D	Description		Photograph
	Maximum depth (m)	1

Maximum width (m)	4	
	Length (m)	70	
	Description	Contributing factors to the erosion included low groundcover and cattle traffic.	
M_Gully_8	Type of erosion feature	Gully	
	Lease Area	B2	
	Landform	Simple slope	
	Location	Upgradient of drainage feature (M_DF_3)	
	Soil Type (Muller, 2008)	Kokotungo	
	ALC (Thompson)	Class A	
	Soil Condition	Texture contrast soils, sodic subsoil and shallow topsoil.

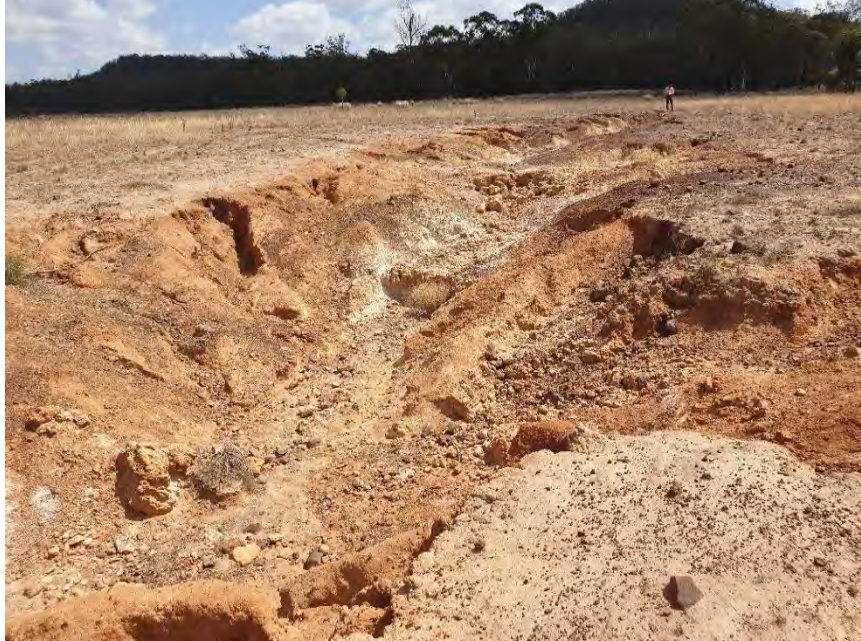
Erosion feature I.D	Description		Photograph
	Top of gully coordinate	Latitude: -24.059255 Longitude: 150.413334

Maximum depth (m)	1	
	Maximum width (m)	20	
	Length (m)	205	
	Description	Contributing factors to the erosion included low groundcover, cattle traffic, steep slopes, shallow topsoil and sodic subsoils.	
M_Gully_9	Type of erosion feature	Gully	
	Lease Area	B2	
	Landform	Simple slope	
	Location	East of cattleyard2	
	Soil Type (Muller, 2008)	Kokotungo	
	ALC (Thompson)	Class A	
	Soil Condition	Texture contrast soils, sodic subsoil and shallow topsoil.

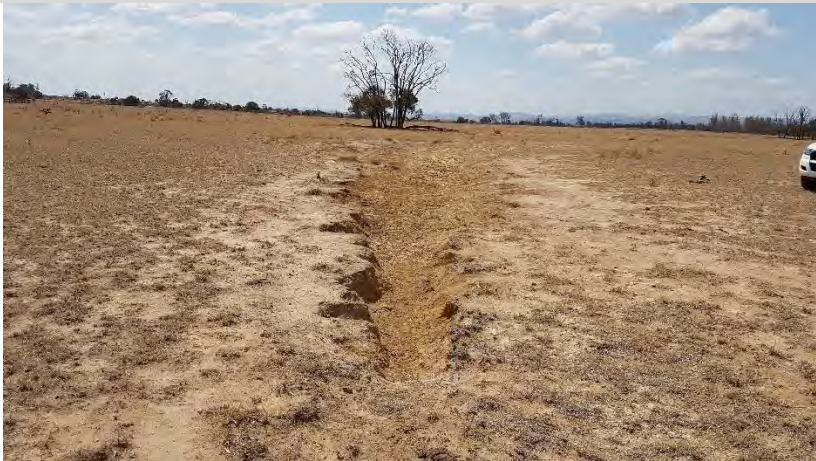
Erosion feature I.D		Description	Photograph
	Top of feature coordinate	Latitude: -24.061241 Longitude: 150.423583

Maximum depth (m)	0.5	
	Maximum width (m)	9	
	Length (m)	35	
	Description	Contributing factors to the erosion included low groundcover, cattle traffic, shallow topsoil and sodic subsoils.	
M_Rill_10	Type of erosion feature	Rill	
	Lease Area	B2	
	Landform	Simple slope	
	Location	West of Dam11	
	Soil Type (Muller, 2008)	Kokotungo	
	ALC (Thompson)	Class A	
	Soil Condition	Texture contrast soils, sodic subsoil and shallow topsoil.	
	Top of feature coordinate	Latitude: -24.061072 Longitude: 150.428054	
	Maximum depth (m)	0.4	
	Maximum width (m)	8	
	Length (m)	80

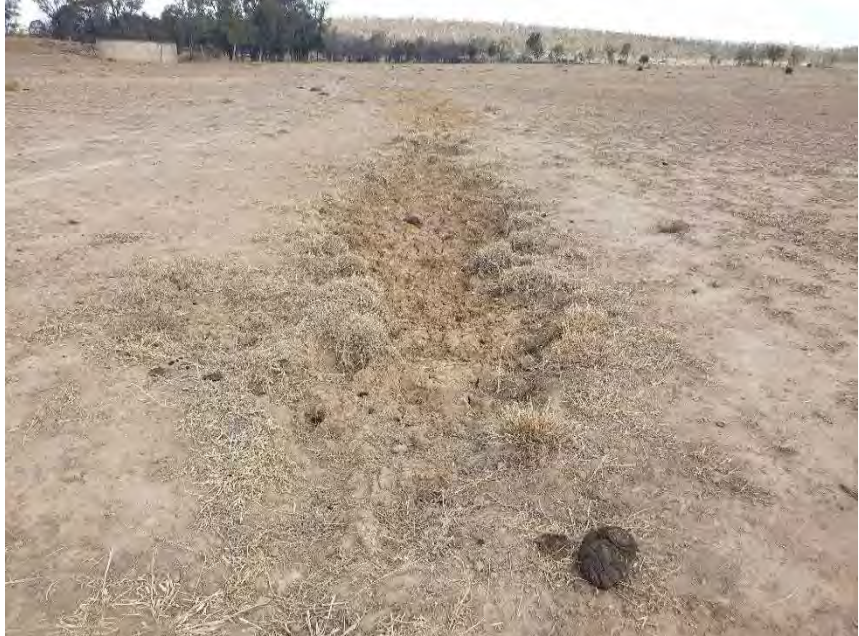
Erosion feature I.D	Description	Photograph
	<div> <div>Description</div> <div>Contributing factors to the erosion included low groundcover and cattle traffic.</div> </div>

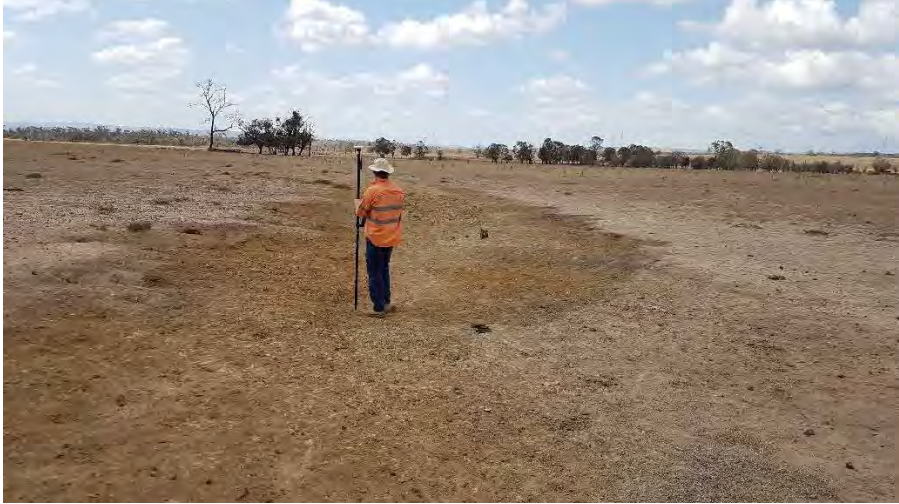
Erosion feature I.D	Description		Photograph
	Top of gully coordinate	Latitude: -24.063676 Longitude: 150.425923

Maximum depth (m)	0.4	
	Maximum width (m)	8	
	Length (m)	35	
	Description	Contributing factors to the erosion included low groundcover and cattle traffic.	
M_Gully_12	Type of erosion feature	Gully	
	Lease Area	B2	
	Landform	Simple slope	
	Location	Southern portion of lease area B2	
	Soil Type (Muller, 2008)	Bluff	
	ALC (Thompson)	Class C	
	Soil Condition	Texture contrast soils, sodic subsoil and shallow topsoil.	
	Top of feature coordinate	Latitude: -24.06644 Longitude: 150.418547	
	Maximum depth (m)	0.6	
	Maximum width (m)	10

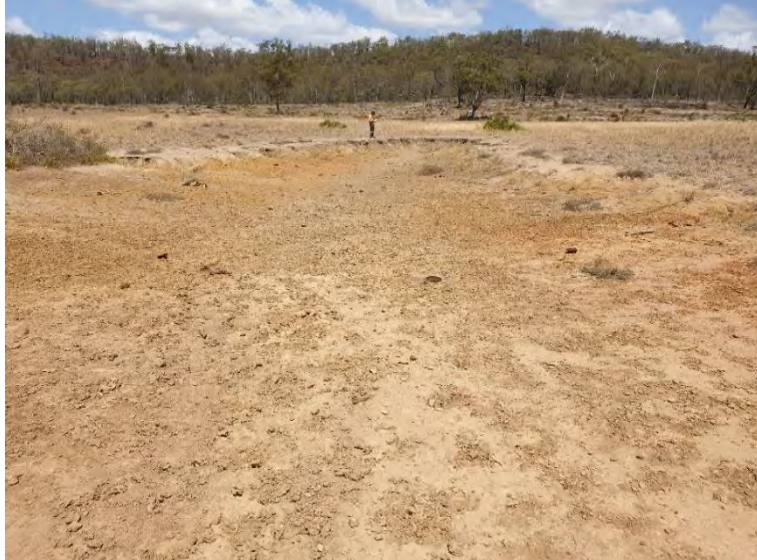
Erosion feature I.D	Description		Photograph
	Length (m)	65

Description	Contributing factors to the erosion included low groundcover, cattle traffic, steep slopes, shallow topsoil and sodic subsoils.	
M_Gully_13	Type of erosion feature	Gully	
	Lease Area	B2	
	Landform	Simple slope	
	Location	Southern portion of lease area B2	
	Soil Type (Muller, 2008)	Kokotungo	
	ALC (Thompson)	Class A	
	Soil Condition	Texture contrast soils, sodic subsoil and shallow topsoil.	
	Top of feature coordinate	Latitude: -24.065527 Longitude: 150.42116

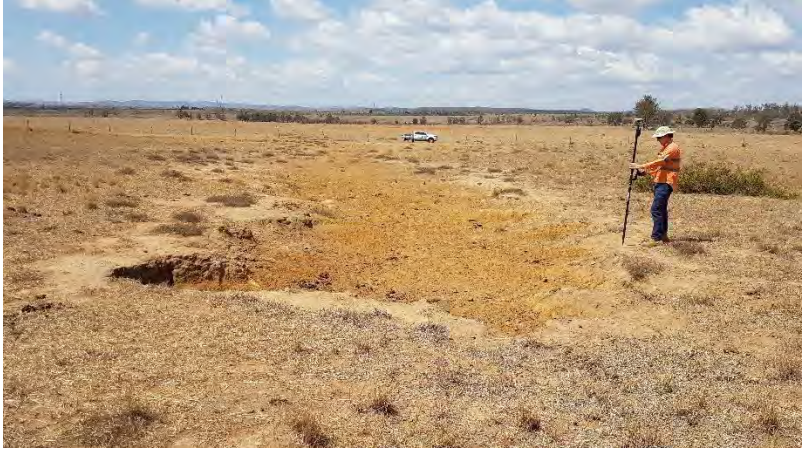
Erosion feature I.D		Description	Photograph
	Maximum depth (m)	0.5

Maximum width (m)	10	
	Length (m)	110	
	Description	Contributing factors to the erosion included low groundcover, cattle traffic, steep slopes, shallow topsoil and sodic subsoils.	
M_DF_3	Type of erosion feature	Erosion of banks of watercourse and lateral bank erosion	
	Lease Area	B2	
	Landform	Watercourse and open depression.	
	Location	Central portion of lease area B2	
	Soil Type (Muller, 2008)	Kokotungo	
	ALC (Thompson)	Class A	
	Soil Condition	Texture contrast soils, sodic subsoil and shallow topsoil.	
	Top of feature coordinate	Latitude: -24.053879 Longitude: 150.423404 Note: start of feature at northern lease area B2 boundary	
	Maximum depth (m)	1	
	Maximum width (m)	170

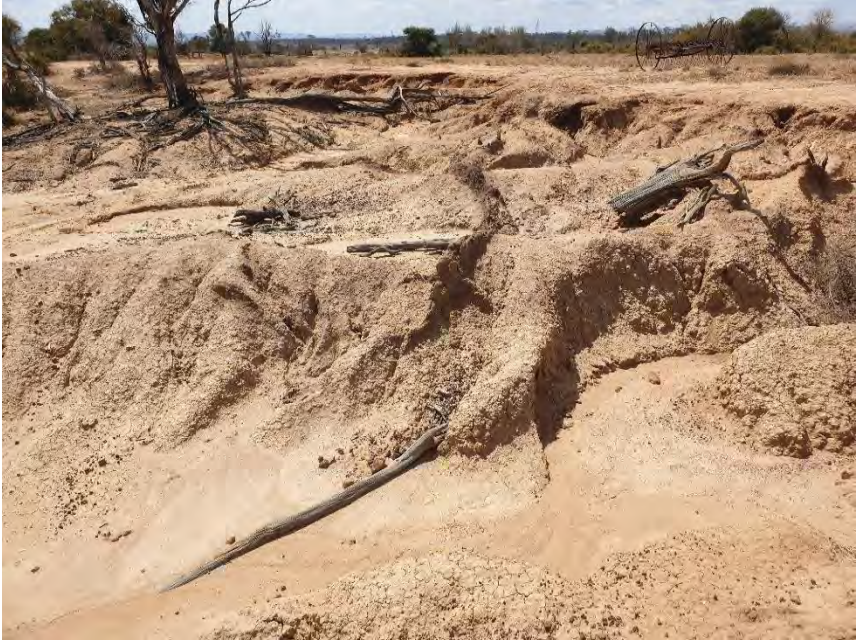
Erosion feature I.D	Description		Photograph
	Length (km)	1.2

Description	<p>Incorporates Dam22.</p> <p>Contributing factors to the erosion included low groundcover, concentrated flow, cattle traffic, shallow topsoil and sodic subsoils. Unstable head and sidewalls and limited upgradient groundcover causing lateral bank erosion.</p> <p>Extends north onto Dunn property.</p>

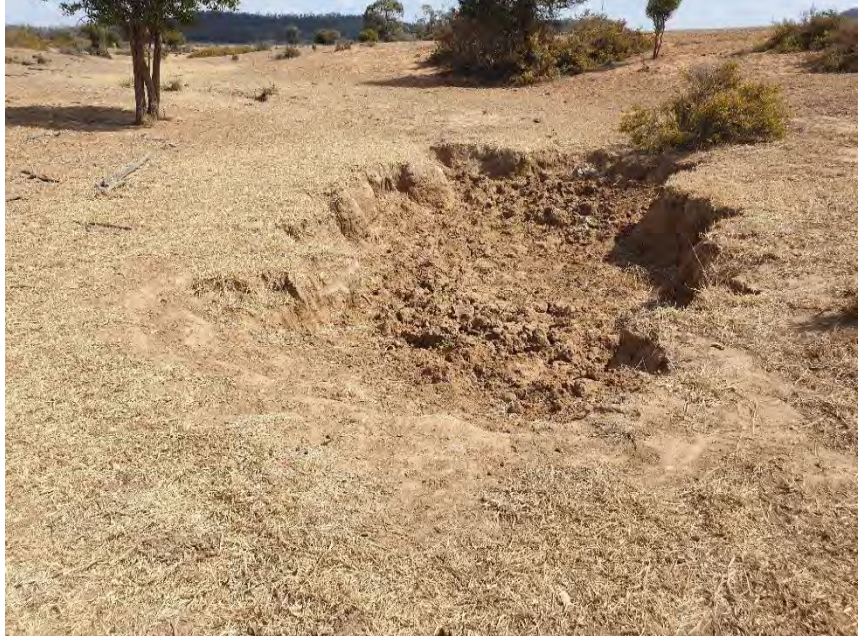
Erosion feature I.D	Description		Photograph
	Maximum depth (m)	0.5

Maximum width (m)	40	
	Length (m)	640	
	Description	Contributing factors to the erosion included low groundcover, cattle traffic, steep slopes, shallow topsoil and sodic subsoils.	
M_EF_3	Type of erosion feature	Minor gullying along watercourse	
	Lease Area	B2	
	Landform	Watercourse and open depression.	
	Location	Upgradient of Dam11	
	Soil Type (Muller, 2008)	Kokotungo	
	ALC (Thompson)	Class A	
	Soil Condition	Texture contrast soils, sodic subsoil and shallow topsoil.

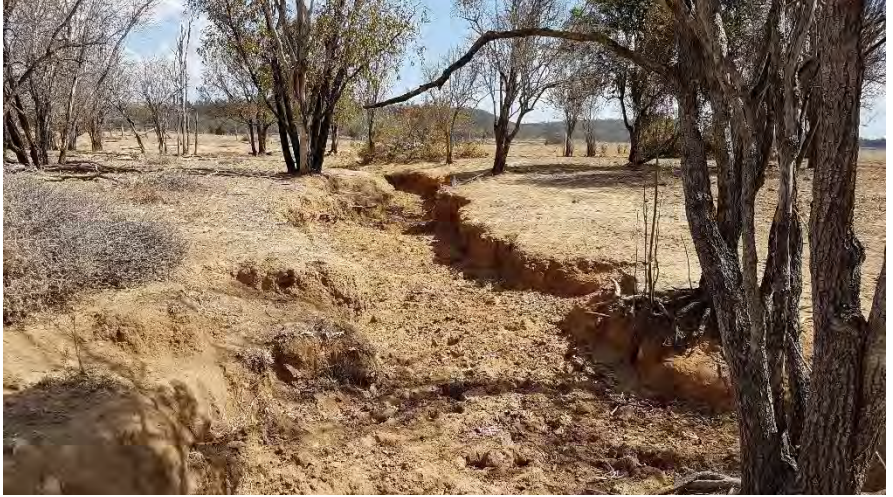
Erosion feature I.D	Description		Photograph
	Top of feature coordinate	Western head Latitude: -24.066466 Longitude: 150.426898 Eastern head Latitude: -24.065877 Longitude: 150.430585

Maximum depth (m)	0.5	
	Maximum width (m)	90	
	Length (m)	565	
	Description	Contributing factors to the erosion included concentrated flow, low groundcover, cattle traffic, shallow topsoil and sodic subsoils.	
M_EF_4	Type of erosion feature	Gully	
	Lease Area	B2	
	Landform	Open depression	
	Location	North of access track	
	Soil Type (Muller, 2008)	Bluff	
	ALC (Thompson)	Class C	
	Soil Condition	Cracking clay soils	
	Top of feature coordinate	Latitude: -24.064725 Longitude: 150.433094	
	Maximum depth (m)	0.4	
	Maximum width (m)	4	
	Length (m)	10

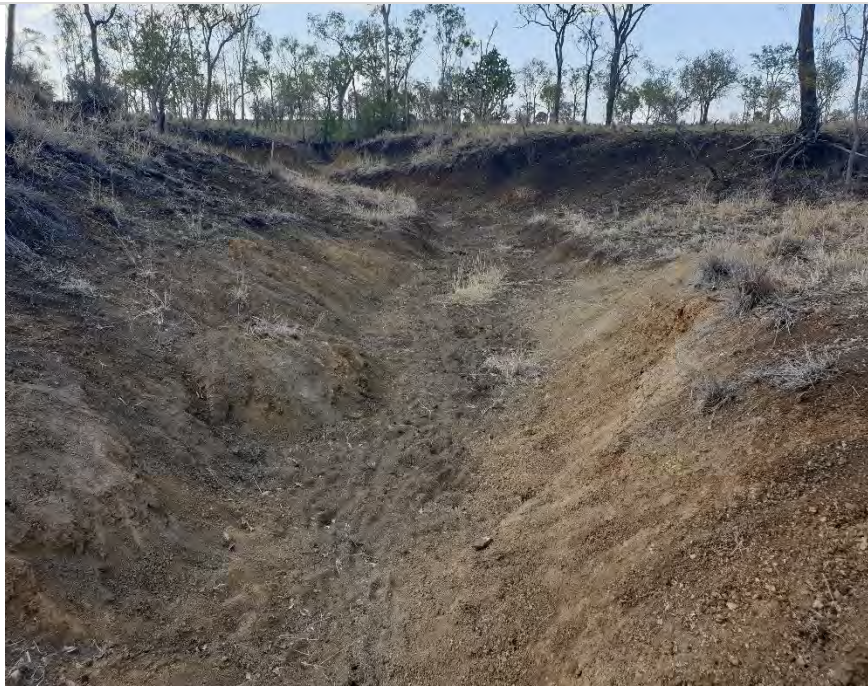
Erosion feature I.D		Description	Photograph
M_Gully_14	Description	Contributing factors to the erosion included concentrated flow along access track, cattle traffic, shallow topsoil and sodic subsoils.

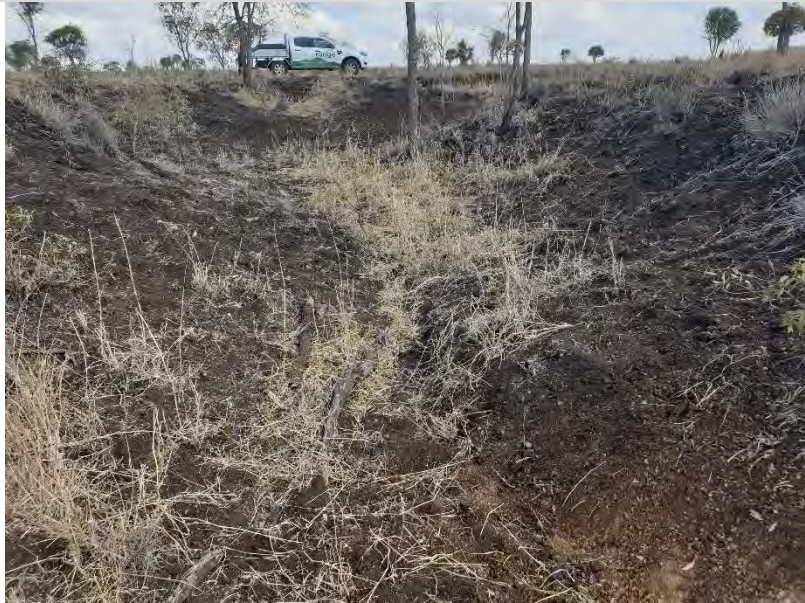
Erosion feature I.D	Description		Photograph
	Soil Type (Muller, 2008)	Clancy

ALC (Thompson)	Class A	
	Soil Condition	Cracking clay soils	
	Top of feature coordinate	Latitude: -24.060447 Longitude: 150.439223	
	Maximum depth (m)	2	
	Maximum width (m)	6	
	Length (m)	95	
	Description	Contributing factors to the erosion included steep slope, concentrated flow, low sidewall groundcover, contour banks and cattle traffic.	
M_Gully_16	Type of erosion feature	Gully	
	Lease Area	B2	
	Landform	Simple slope	
	Location	South-west of powerlines	
	Soil Type (Muller, 2008)	Santo	
	ALC (Thompson)	Class C	
	Soil Condition	Cracking clay soils	
	Top of feature coordinate	Latitude: -24.064806 Longitude: 150.442652

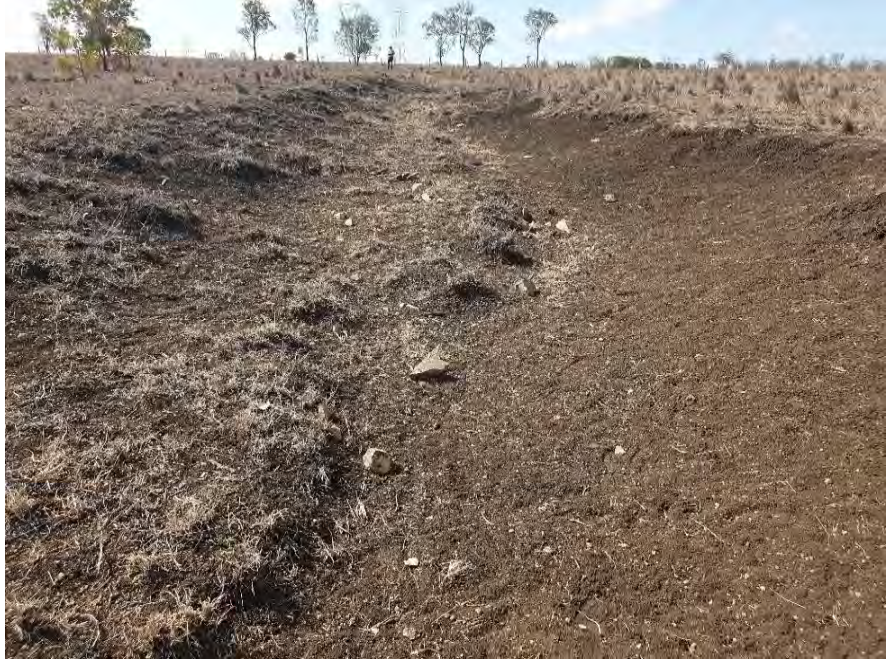
Erosion feature I.D	Description		Photograph
	Maximum depth (m)	1

Maximum width (m)	7	
	Length (m)	75	
	Description	Contributing factors to the erosion included steep slope, contour banks and cattle traffic.	
M_DF_4	Type of erosion feature	Erosion of banks of watercourse and lateral bank erosion	
	Lease Area	B2	
	Landform	Open depression/ watercourse	
	Location	South of Dodson Road	
	Soil Type (Muller, 2008)	Clancy	
	ALC (Thompson)	Class A	
	Soil Condition	Cracking clay soils
