Edify Energy – Development Plans

PROJECT
SMOKY CREEK SOLAR PROJECT

LAND CONDITION ASSESSMENT Smoky Creek Solar Farm

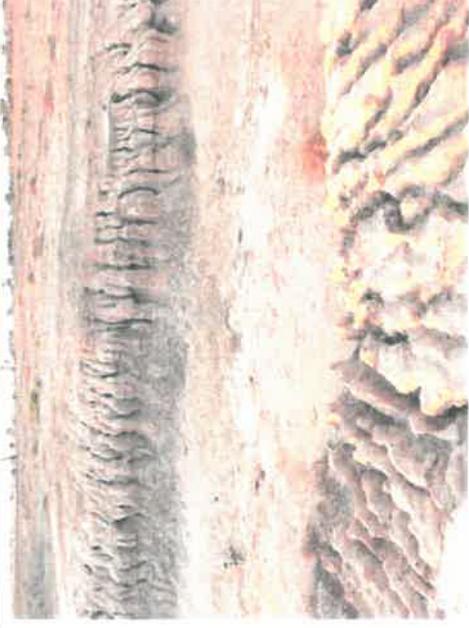
Constraint	Description	Soils	Representative Photograph
Dispersive soils	<ul style="list-style-type: none"> Dispersive soils include soils with an Exchangeable Sodium Percentage (ESP) of 15 or more or a Ca:Mg ratio <0.1. Dispersive soils present a high erosion risk if exposed. They also impede drainage and root growth. Topsoil (A horizon) is not normally dispersive soil. Dispersive soils commonly occur in the subsoil (B horizon). Dispersive soils at the site are mainly associated with gilgai soils (from 0.2 m) and texture contrast soils (from 0.2 m). Dispersive soils occur at 0.8 m for Earlsfield soils (Vertosols). Soils with dispersive soils in their profile occur across 75% of the lease areas. 	Bluff, Desdemona, Earlsfield, Greycliffe, Greycliffe Melonhole Phase, Kokotungo and Ulogie.

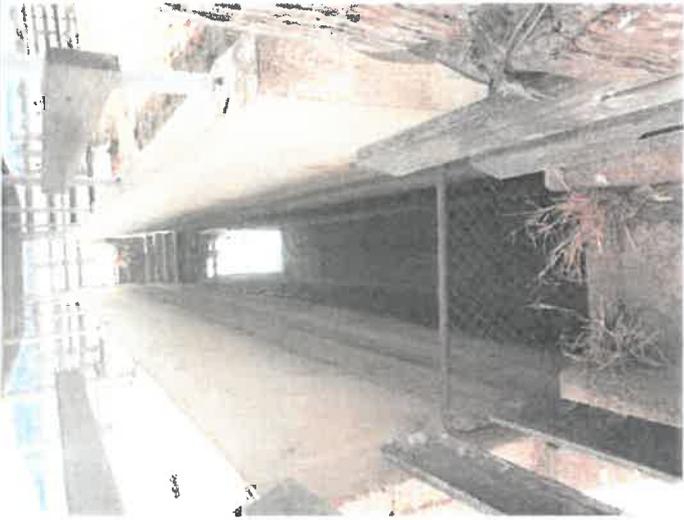
Constraint	Description	Soils	Representative Photograph
Contaminated soil	<ul style="list-style-type: none"> • Cattle dips were located at Lease Areas A and E. • Common soil contaminants at cattle dips include arsenic and DDT. • Contamination at cattle dips is usually localised to the dip area (i.e. nominally within 30m of the dip and associated infrastructure⁵). 	Greycliff and Kokotungo

<p data-bbox="1018 584 1048 1030">View to the east of a livestock plunge dip</p>

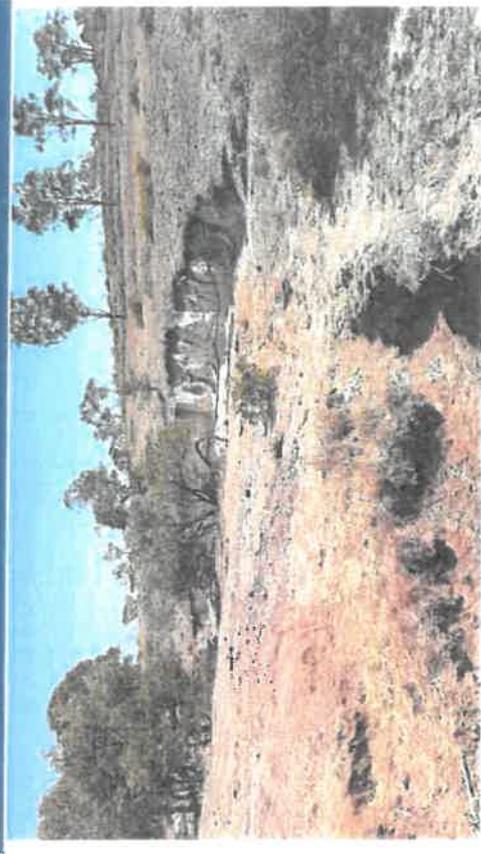
Constraint	Description	Soils	Representative Photograph
Steep slopes	<ul style="list-style-type: none"> Steeply sloping land exceeds 3%. Steeply sloping land occurs in lease areas A, B1, B2, D2 and G2 Steeply sloping land, particularly where dispersive soils occur, can increase the risk of erosion for land disturbing activities for agriculture or construction. 	Annandale, Belldeen, Bluff, Clancy, Earlsfield, Greycliffe, Melonhole Phase, Greycliffe, Kokotungo, Santo Fertile Phase, Santo Stony Phase, Spier, Ulogie

View to the north of steeply sloping land.

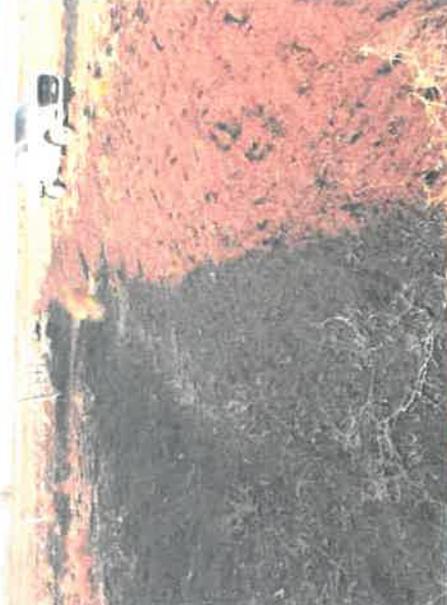
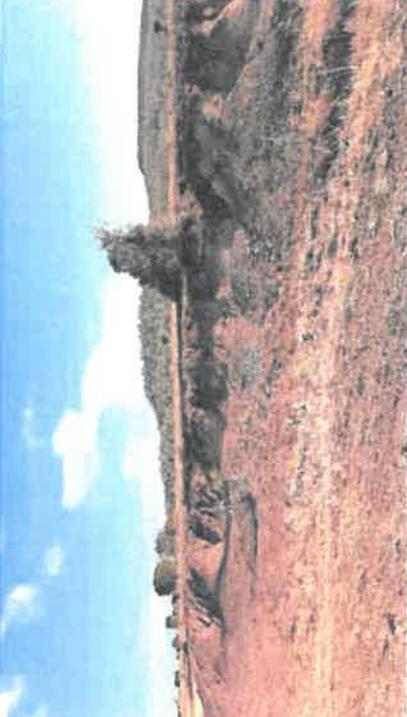
Type of erosion feature	Rill
Lease Area	E
Landform	Simple slope
Location	Formed from cattle track
Soil Type (Muller, 2008)	Annandale
ALC (Thompson)	Class A
Soil Condition:	Cracking clay soils
Rill head coordinate	Latitude: -24.047835 Longitude: 150.418234
Maximum depth (m)	0.4
Maximum width (m)	3
Length (m)	310

Erosion feature I.D	Description	Photograph
D_DF_1	<p>Description</p> <p>Rill erosion with head formed at cattle track. Gently inclined sidewalls.</p>

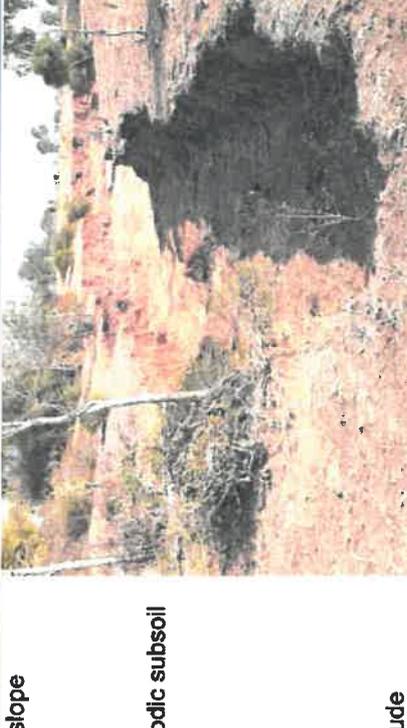
Erosion feature I.D	Description	Photograph
D_DF_6	<p>Watercourse and lower slope Downgradient of Dam Kokotungo ALC A Texture contrast soils, sodic subsoil and shallow topsoil. Latitude: -24.0484 Longitude: 150.425296 Range from <0.5->2 50 1.56 Contributing causes include concentrated flow from upgradient watercourses and dams, groundcover and dispersive subsoils. Unstable sidewalls and limited upgradient groundcover. Evidence of lateral bank erosion at some locations. Erosion of banks of watercourse & rill G2 Watercourse & lower slope Gully erosion formed at upgradient property east of the site and extended onto the site. Clancy</p>

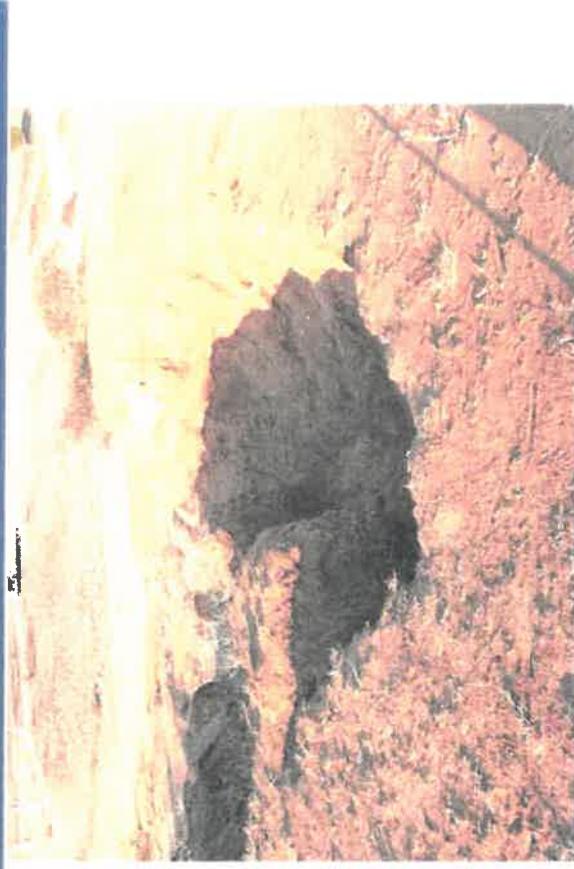
Gully
 G2
 Upper slopes and crest
 Lateral bank erosion from watercourse.
 Santo
 Class C
 Friable non-cracking clay or clay loam soils
 Latitude: -24.038453
 Longitude: 150.435185
 3
 20
 140

Contributing factors to the erosion included low groundcover, steep slope and sodic subsoils. Unstable sidewalls and limited upgradient groundcover.

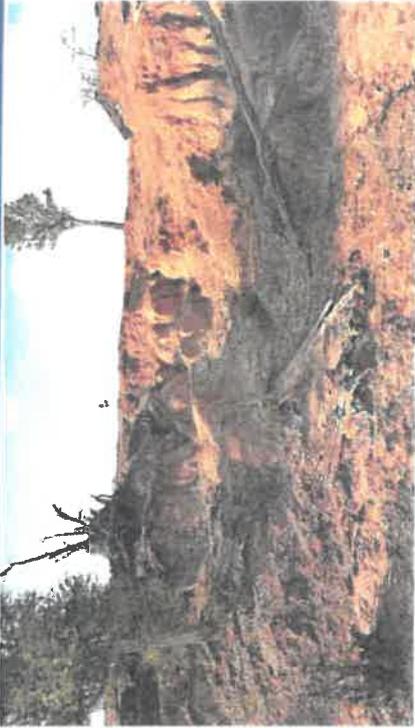
D_DF_2	Erosion of banks of watercourse
Lease Area	G2
Landform	Watercourse and lower slopes.
Location	Erosion formed from watercourse originating upgradient property north of the site and extended onto the site.
Soil Type (Muller, 2008)	Kokotungo
ALC (Thompson)	ALC A
Soil Condition:	Texture contrast soils, sodic subsoil and shallow topsoil.

Erosion feature I.D	Description	Photograph
3	<p>Top of feature coordinate Latitude: -24.036238 Longitude: 150.421</p> <p>Maximum depth (m) 16</p> <p>Maximum width (m) 450</p> <p>Length (m) 450</p> <p>Description Contributing factors to the erosion included low groundcover, steep slope and sodic subsols. Unstable sidewalls and limited upgradient groundcover.</p>

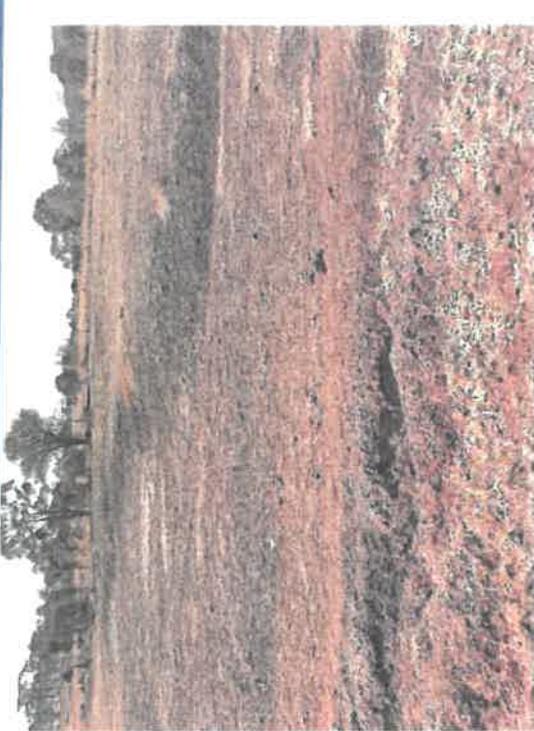
F_Rill_1	<p>Type of erosion feature Lease Area Landform Location Soil Type (Muller, 2008) ALC (Thompson) Soil Condition: Rill head coordinate Maximum depth (m) Maximum width (m) Length (m) Description</p>	<p>Rill C Lower slope Adjoining Dodsons Road Kokotungo Class C Friable non-cracking clay or clay loam soils Latitude: -24.044339 Longitude: 150.400246 0.5 30 110 Contributing factors to the erosion included low groundcover and cattle traffic.</p>

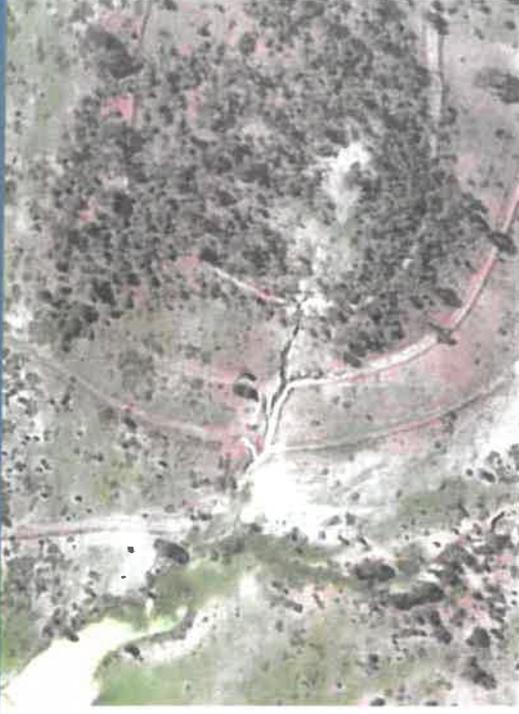
Erosion feature I.D	Description	Photograph
F_Gully_4	<p> Maximum depth (m) 0.5-2 Maximum width (m) 5-15 Length (km) 1.8 Description Contributing factors to the erosion included low groundcover, cattle tracking and sodic subsoils. Unstable head and sidewalls (including of banks) and limited upgradient groundcover. Type of erosion feature Gully Lease Area D2 Landform Upper slope Location East of Dodsons Road Soil Type (Muller, 2008) Kokotungo ALC (Thompson) ALC C Soil Condition: Texture contrast soils, sodic subsoil and shallow topsoil. Gully head coordinate Latitude: -24.028504 Longitude: 150.401092 Maximum depth (m) 1.2 Maximum width (m) 3 Length (m) 175 Description Contributing factors to the erosion included contour banks and sodic subsoils. Unstable head and sidewalls (including of banks) and limited upgradient groundcover. Secondary gullies formed. </p>

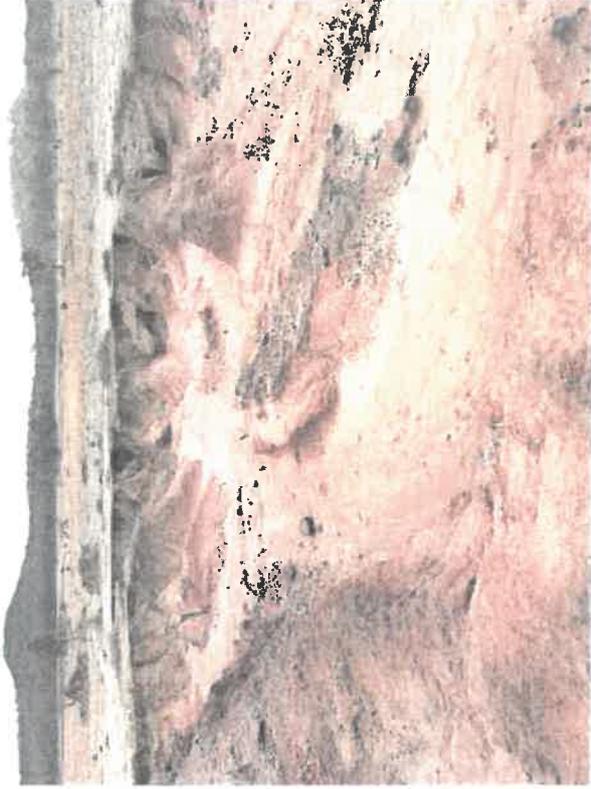
M_DF_1	<p>180 (east to west) 290 (north to south) Contributing factors to the sheet erosion include unstable ground surface condition, low groundcover and cattle tracking.</p> <p>Erosion of banks of watercourse and lateral bank erosion and gullies.</p> <p>A Watercourse Erosion of banks of watercourse Spier & Kokotungo</p> <p>Class A Texture contrast soils, sodic subsoil and shallow topsoil. Latitude: -24.068399 Longitude: 150.392243 Note: start of feature at eastern lease boundary</p> <p>6 90 1.8</p> <p>Contributing factors to the erosion included low groundcover, concentrated flow, cattle traffic, shallow topsoil and sodic subsoils. Unstable head and sidewalls and limited upgradient groundcover causing lateral bank erosion.</p>

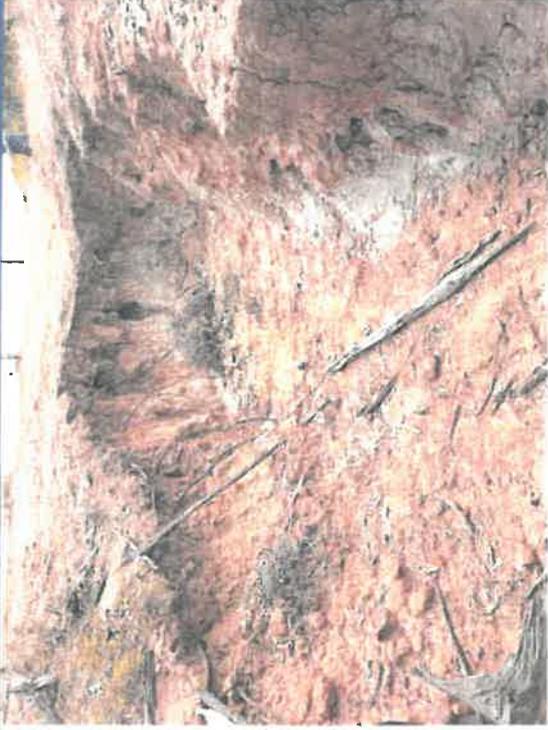
Significant gully erosion adjoining dam.

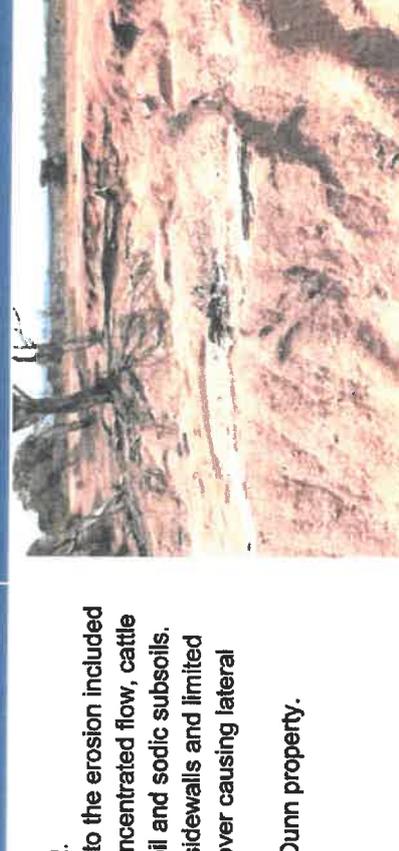
M_DF_3
 Type of erosion feature Erosion of banks of watercourse and lateral bank erosion
 Lease Area B2
 Landform Watercourse and open depression.
 Location Central portion of lease area B2
 Soil Type (Muller, 2008) Kokotungo
 ALC (Thompson) Class A
 Soil Condition Texture contrast soils, sodic subsoil and shallow topsoil.
 Top of feature coordinate Latitude: -24.053879
 Longitude: 150.423404
 Note: start of feature at northern lease area B2 boundary
 Maximum depth (m) 1
 Maximum width (m) 170

Erosion feature I.D	Description	Photograph
1.2	<p>Incorporates Dam22.</p> <p>Contributing factors to the erosion included low groundcover, concentrated flow, cattle traffic, shallow topsoil and sodic subsoils. Unstable head and sidewalls and limited upgradient groundcover causing lateral bank erosion.</p> <p>Extends north onto Dunn property.</p>

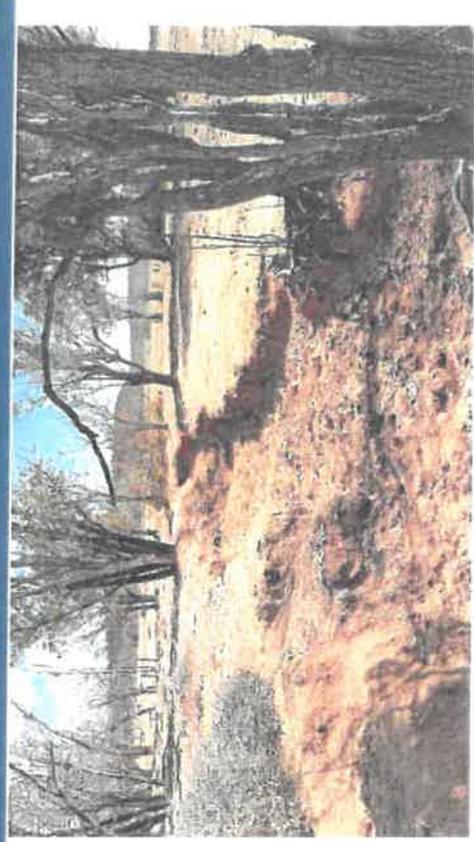
<p>Type of erosion feature Minor gulying along watercourse</p>	
	<p>Lease Area B2</p>	
	<p>Landform Watercourse and open depression.</p>	
	<p>Location Upgradient of Dam11</p>	
	<p>Soil Type (Muller, 2008) Kokotungo</p>	
	<p>ALC (Thompson) Class A</p>	
	<p>Soil Condition Texture contrast soils, sodic subsoil and shallow topsoil.</p>

Top of feature coordinate
 Western head
 Latitude: -24.066466
 Longitude: 150.426898
 Eastern head
 Latitude: -24.065877
 Longitude: 150.430585

Maximum depth (m) 0.5
Maximum width (m) 90
Length (m) 565
Description
 Contributing factors to the erosion included concentrated flow, low groundcover, cattle traffic, shallow topsoil and sodic subsoils.
